THE STATE OF YOUR CREEK

Love Creek on Rehoboth Bay

The Love Creek Report

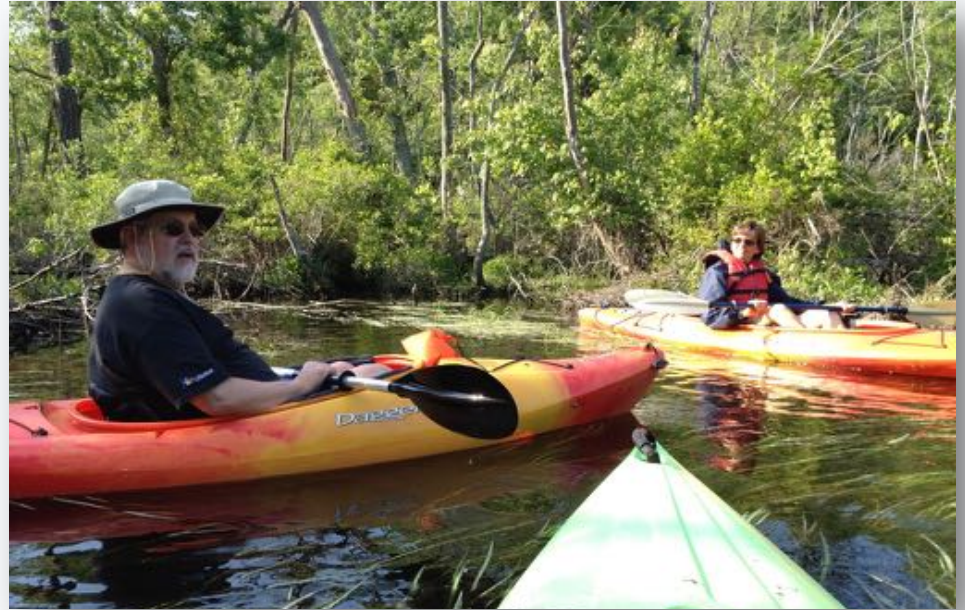
BACTERIA POLLUTION: Levels are too high

Love Creek water exceeds the safe standard roughly 20% of the time (during the swimming season)

The overall trend shows this is getting worse.

Identifying and removing sources of harmful bacteria needs to be a priority.

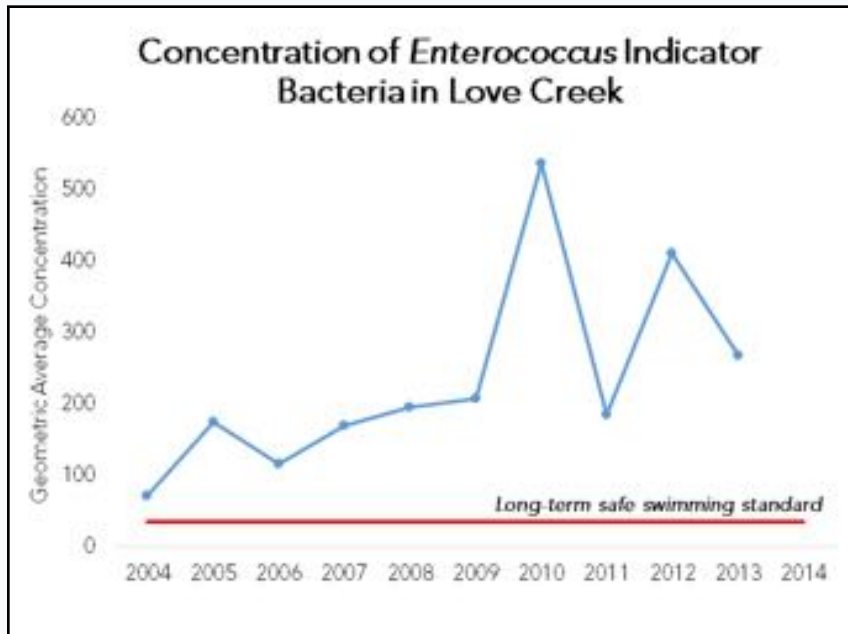
BACTERIA POLLUTION: Levels are too high

- Average fecal bacteria levels from June – September **exceed the safe swimming standard in Love Creek.**
- DNREC ordered a portion of Love Creek **closed to all commercial and recreational shellfish harvesting** due to increased bacteria levels.
