The Anchorage Canal Drainage Area Stormwater Retrofit Project

Chris Bason & Dr. Marianne Walch, *Delaware Center for
the Inland Bays*

*Presentation to CIB Board of Directors
December 15, 2017*

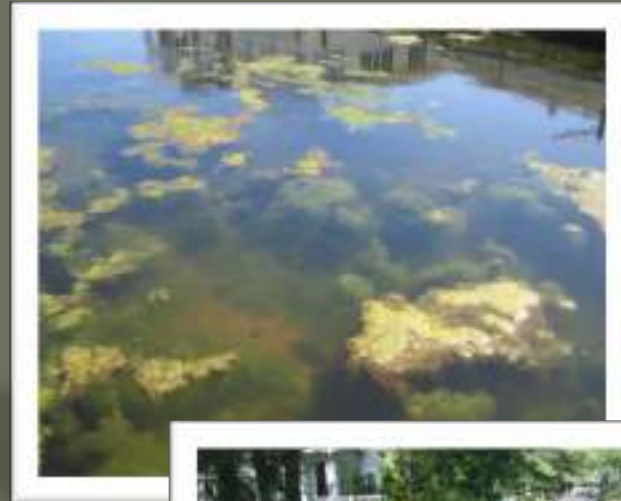
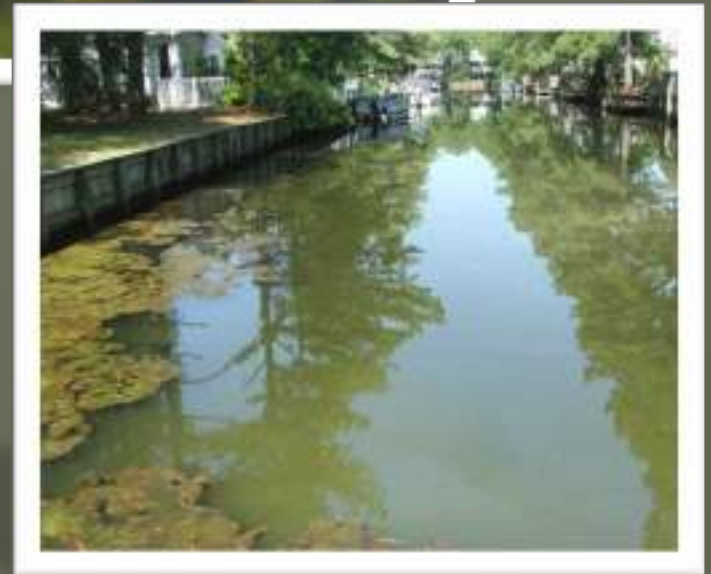
Anchorage Canal Surface Drainage Area & Communities

Anchorage Canal is a part of the Town of South Bethany canal system on Little Assawoman Bay.

- Highly impervious drainage area (~50%), largest of all residential canals
- Receives runoff from storm drains under Rte. 1
- High pollutant loads
 - *592 lbs N/yr*
 - *33 lbs P/yr*
 - *First flush Coliforms 90,000-800,000 units*
- Highly eutrophic
- No MS4

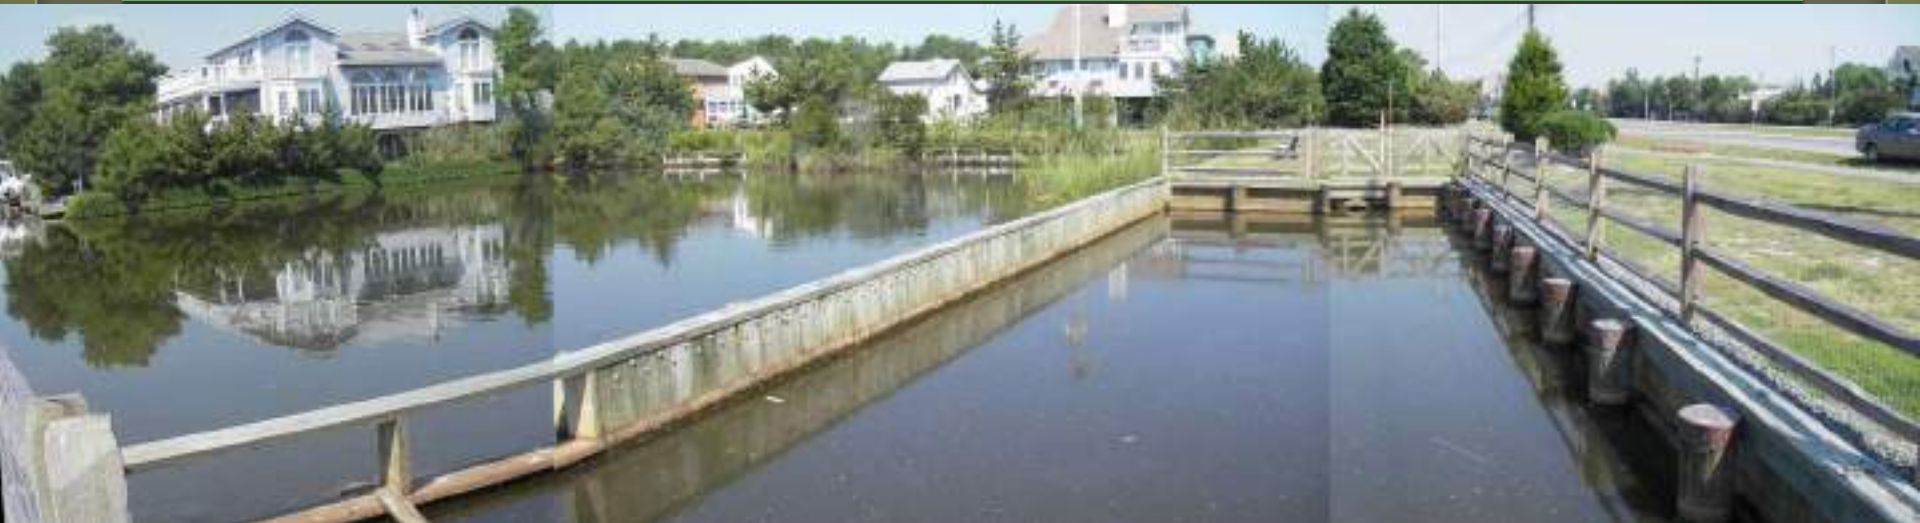
Sediment Control Forebay

- Installed in 2004
- 16.5 yd³ of sediment enter annually
- Initially 28% efficient at sediment capture

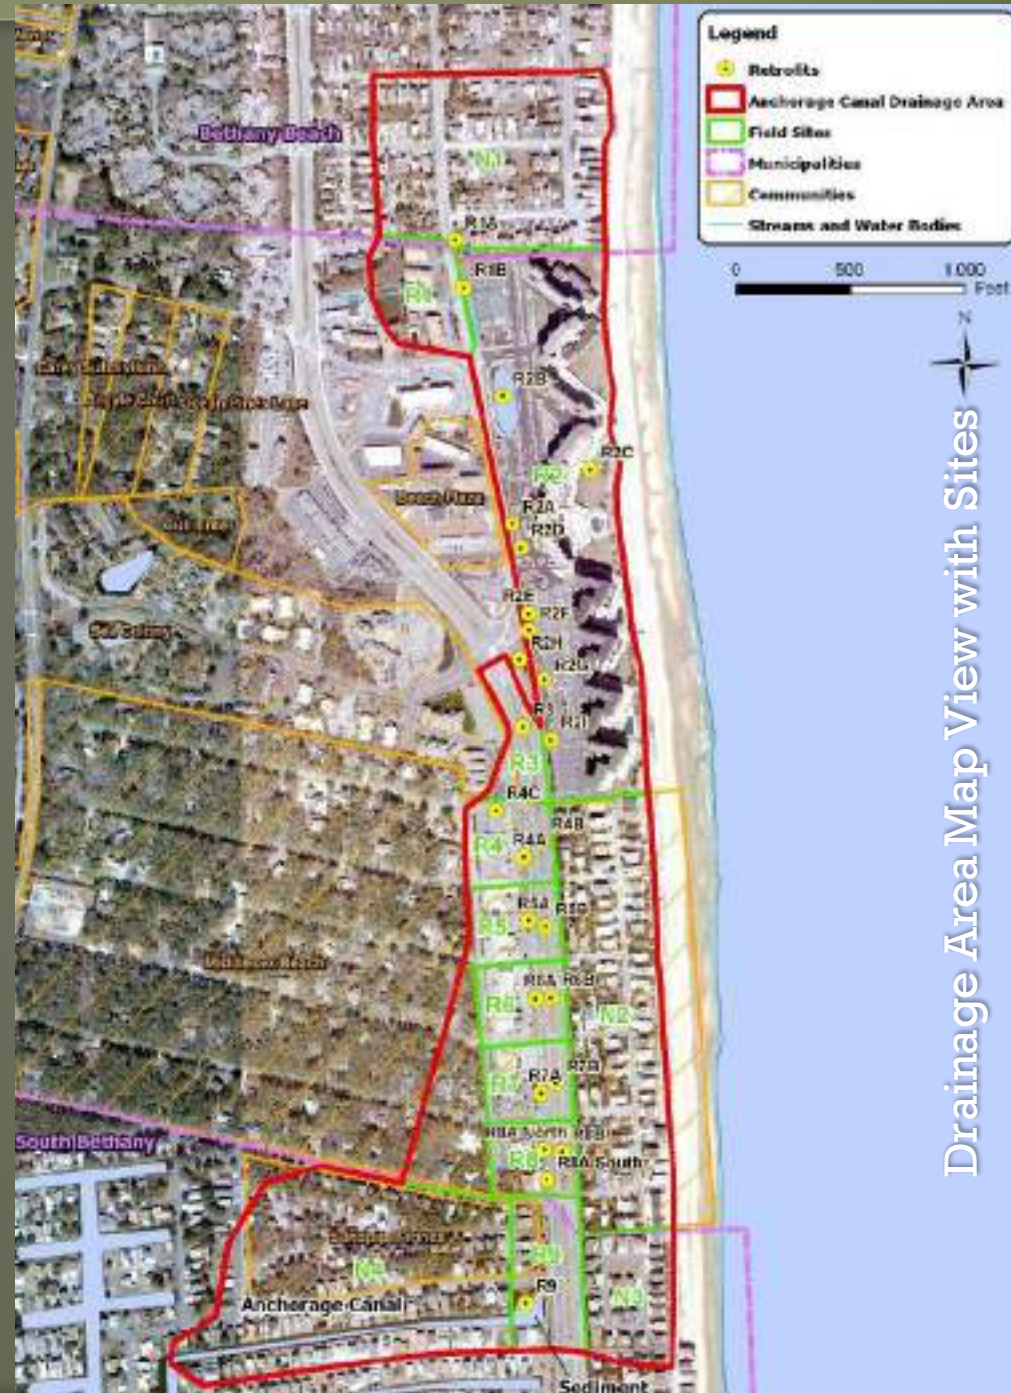
Retrofit Reconnaissance Inventory

- Purpose
 - Verify feasibility of candidate retrofit sites
 - Collect information
- Key tasks
 - Evaluate potential retrofit sites, collect pertinent site information, and produce a basic concept design sketch

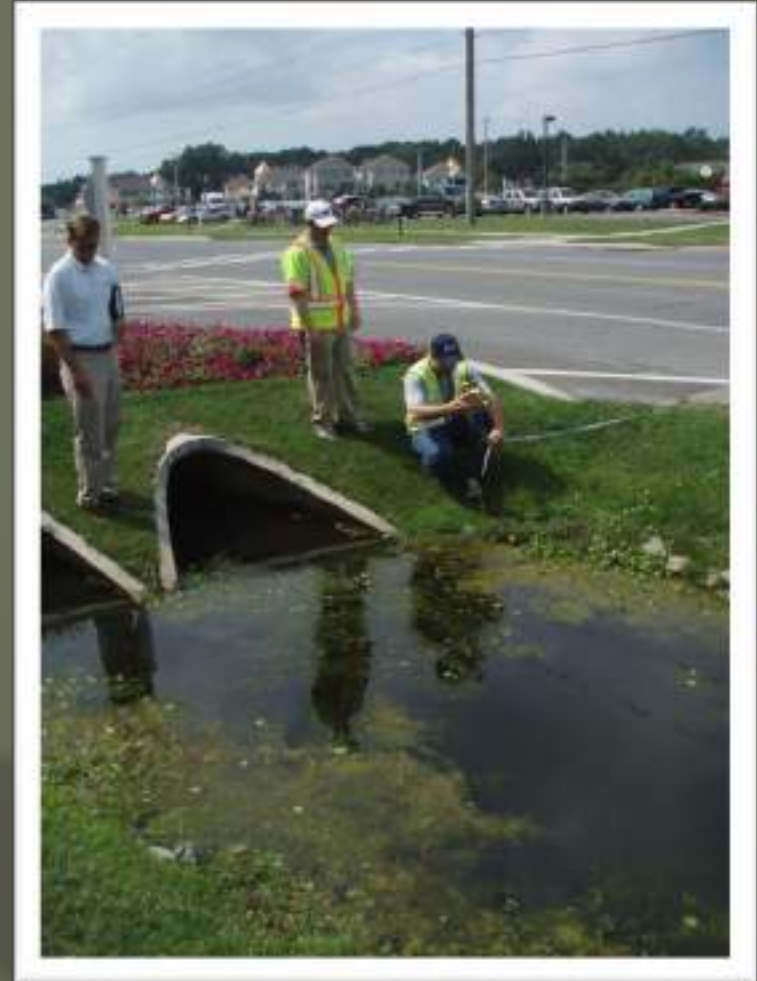
Project 1: Wet Swale and Infiltration Pits

- Treated 30 - 40 ac. of high rise condo facility
- Installed 19 parking lot curb cuts and infiltration pits
- Converted existing ditch to planted wet swale with roadside filter strips

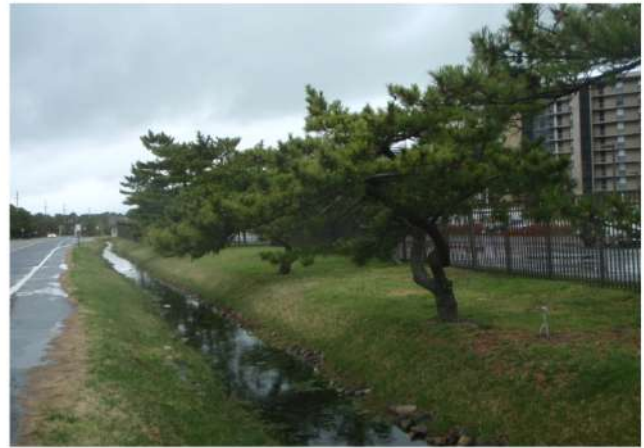
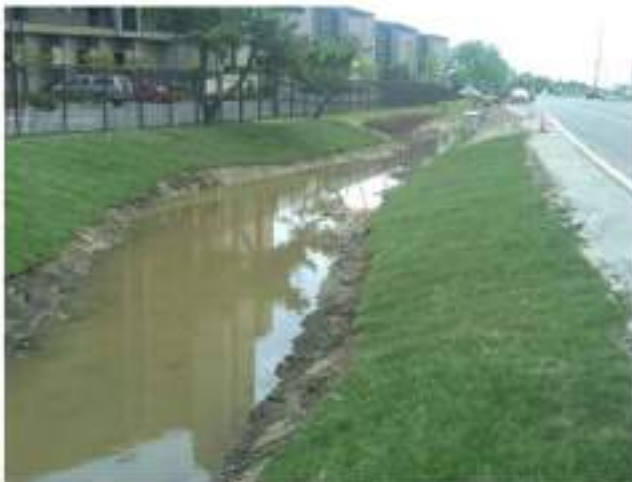
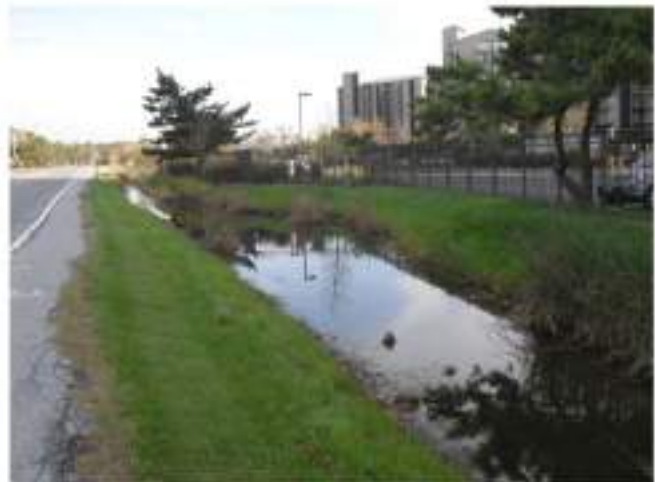
Project 1: Wet Swale with Check Dams

- Converted existing ~1 mi. long ditch to wet swale with check dams and planted.
- Regraded along PA Ave. shoulder to provide filter strip.
- \$190,913 total cost (cash + in-kind services)

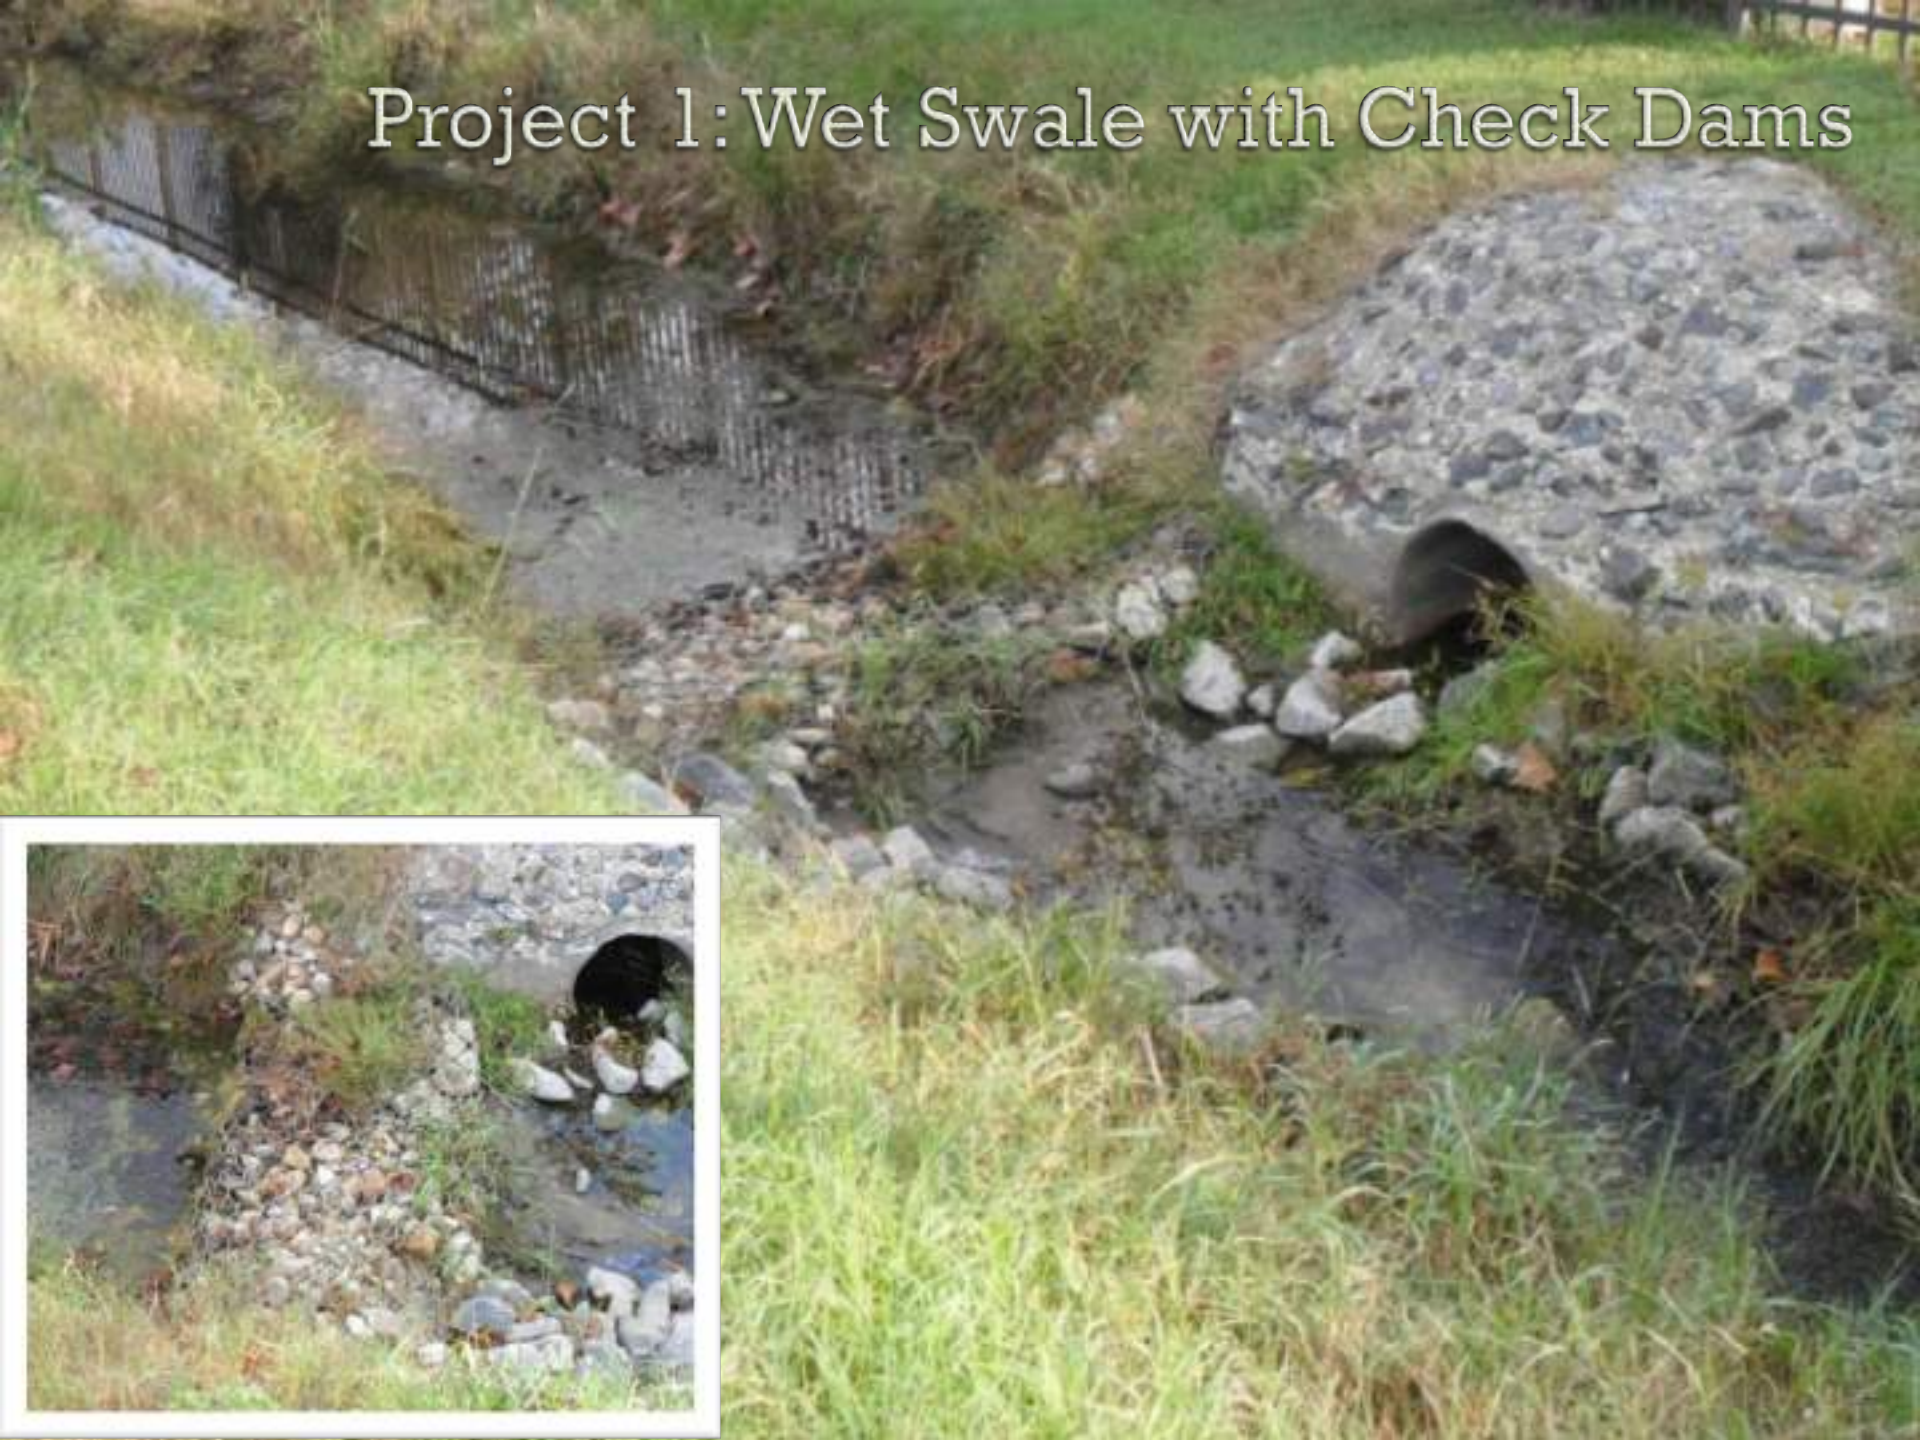
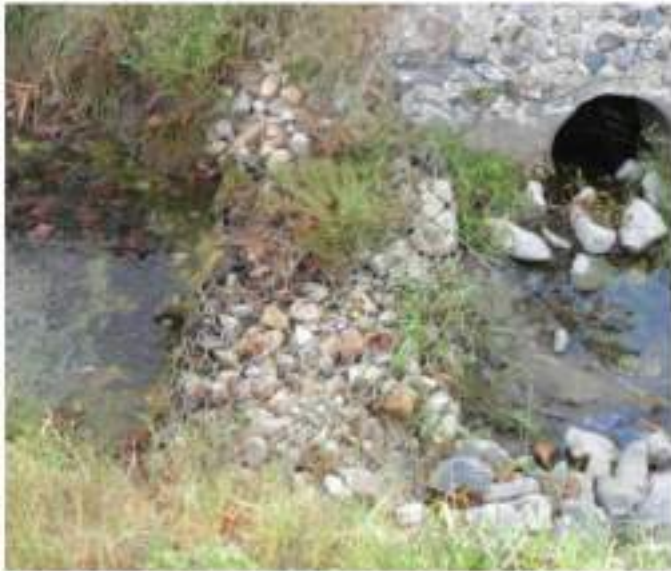
Wet Swale Performance

- Exemplary vegetation maintenance by Sea Colony Condo Assoc.
- High plant diversity and habitat value
 - Fish
 - Turtles
 - Herons
 - Muskrats
- No structural issues
- Natural appreciation and education values

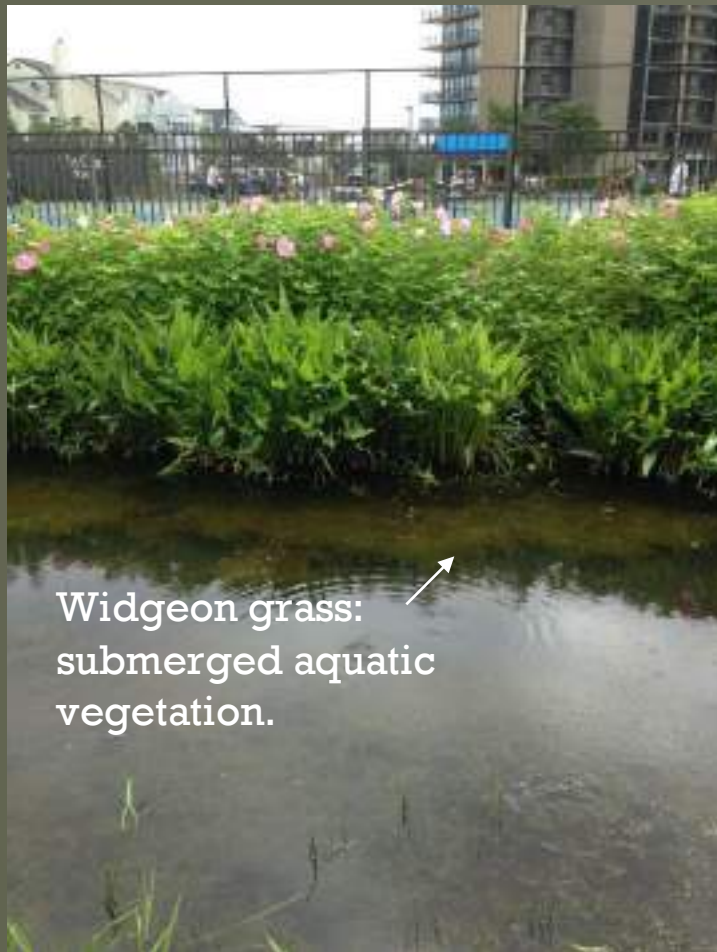
Widgeon grass:
submerged aquatic
vegetation.

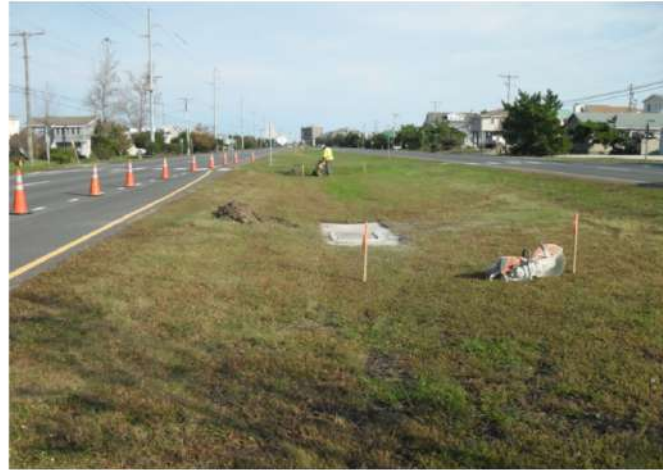
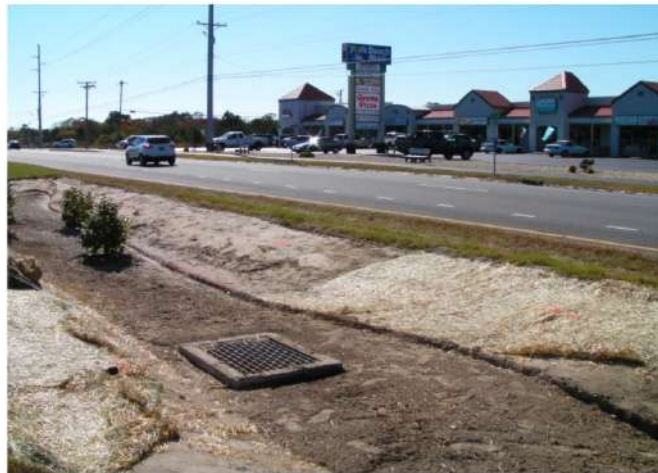
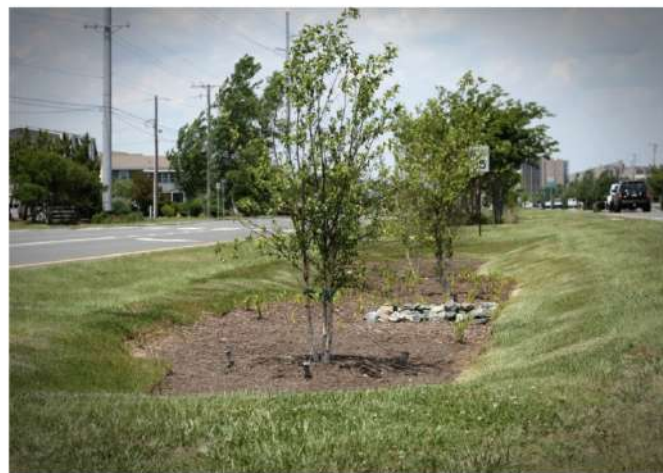
Projects 2 & 3 Highway Bioretention Areas

- 33 highway bioretention areas treated ~20 ac. of highway and residential runoff.
- Utilized medians and ROWs.
- Conducted in two phases.

Grade-all
excavation was
careful not to
damage catch
basins.

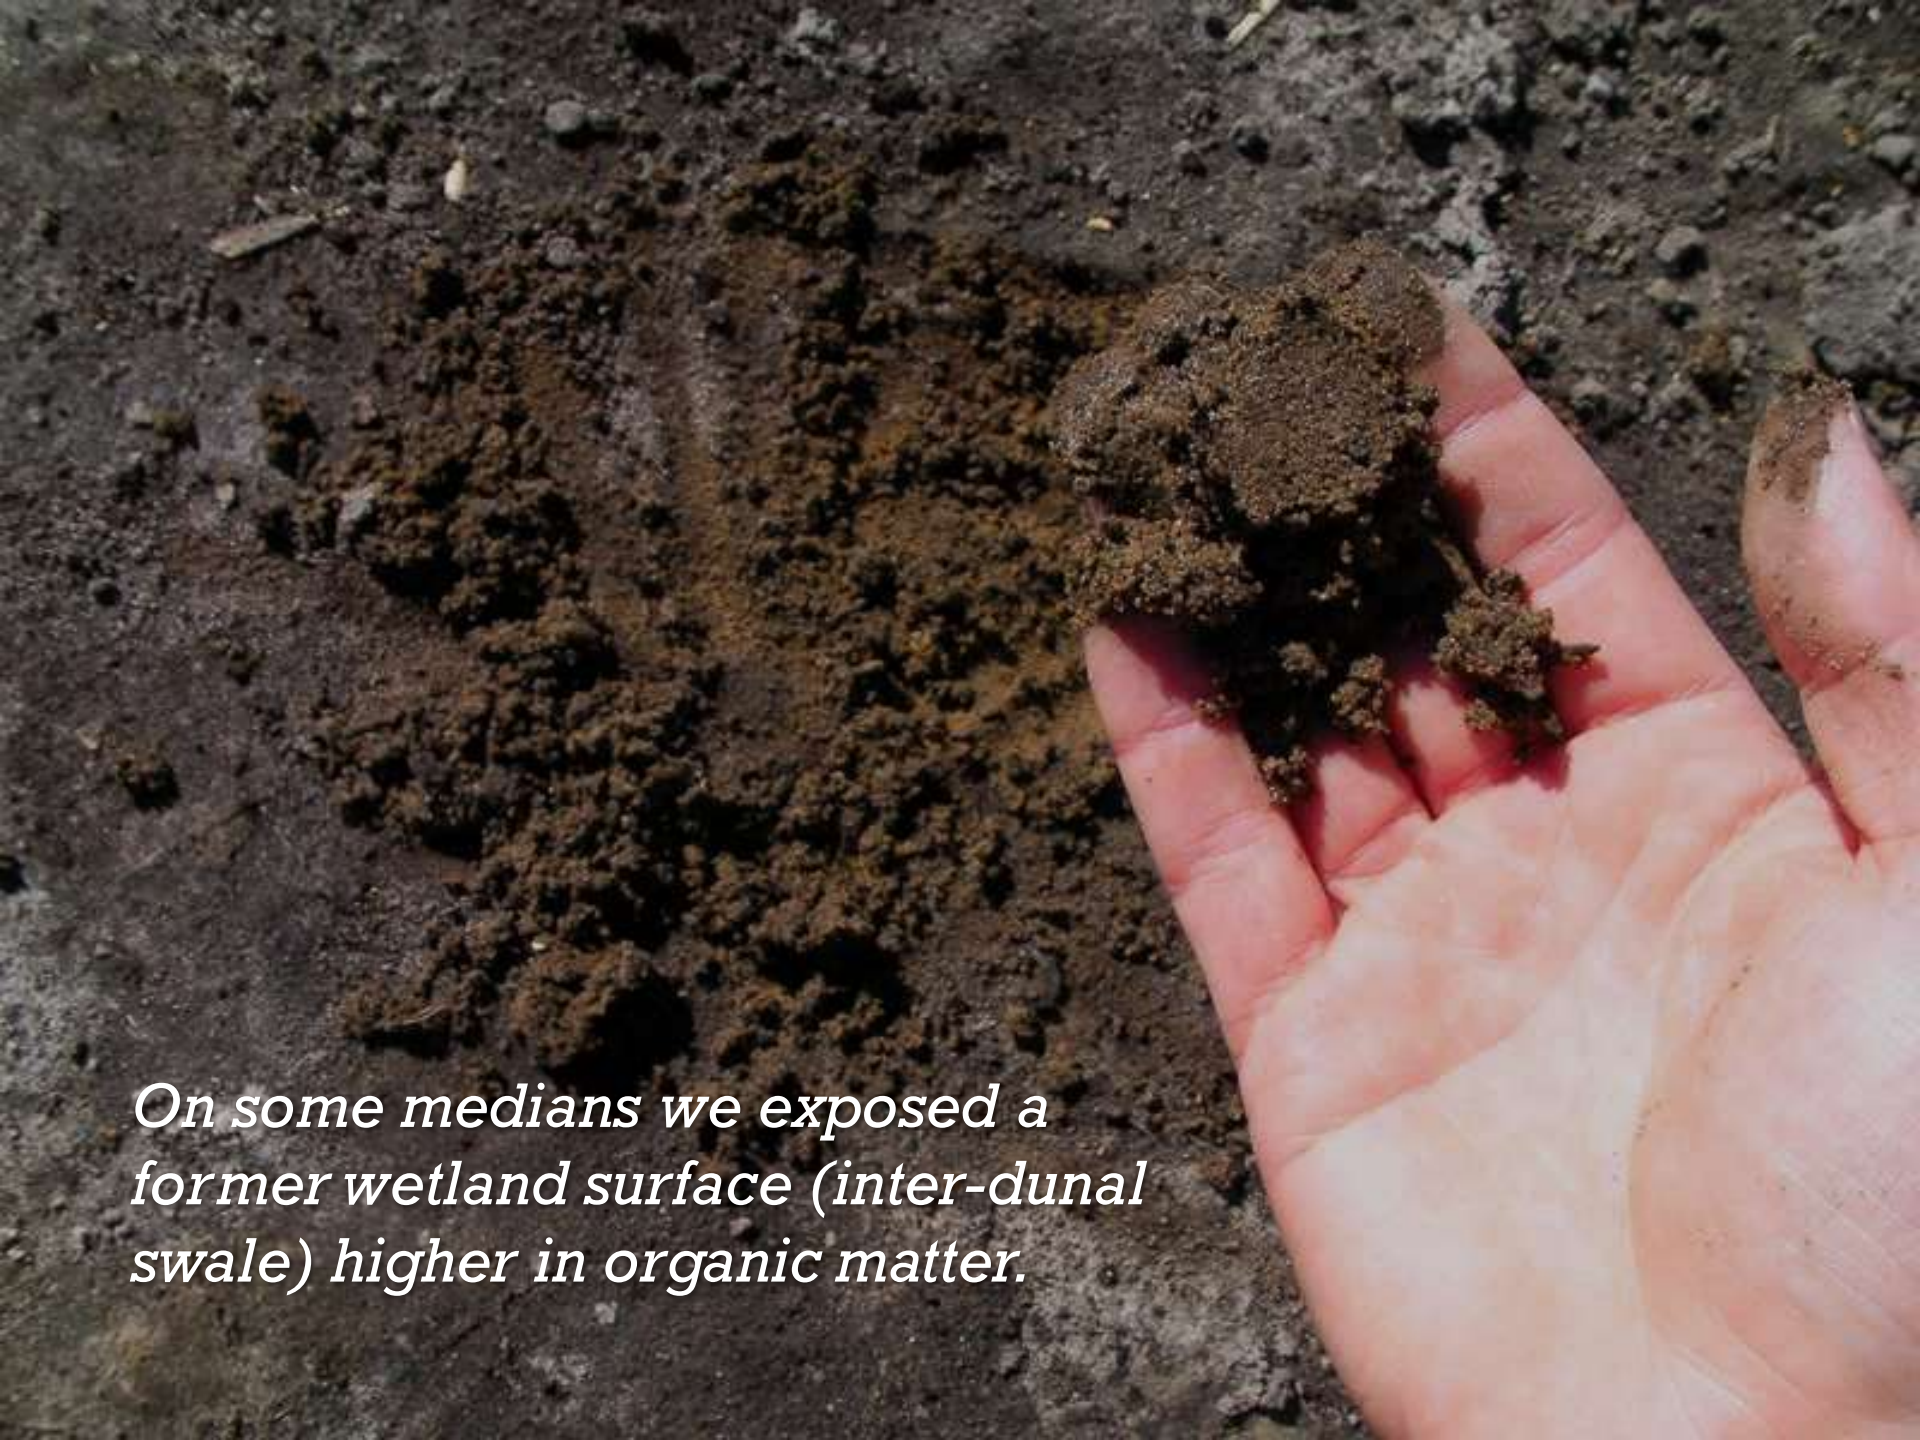
A close-up photograph showing a person's hand holding a clump of dark, moist, and crumbly soil. The soil has a rich, dark brown to black color, indicating high organic content. In the background, there is a larger, similar pile of soil on a dark, textured surface. The lighting is bright, highlighting the texture of the soil and the skin of the hand.

On some medians we exposed a former wetland surface (inter-dunal swale) higher in organic matter.

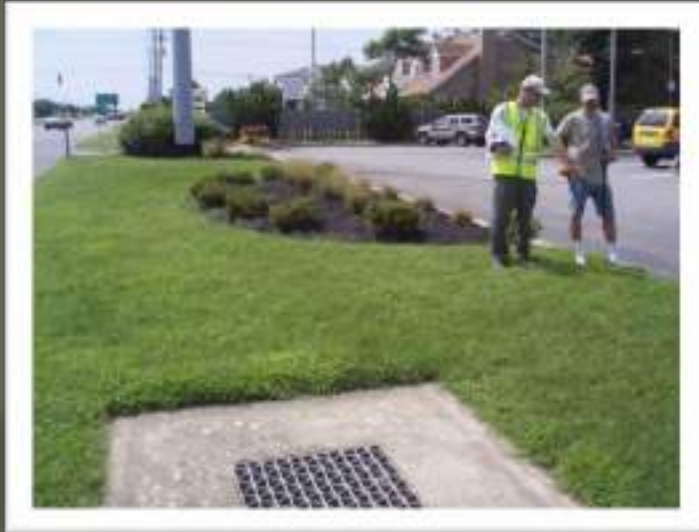
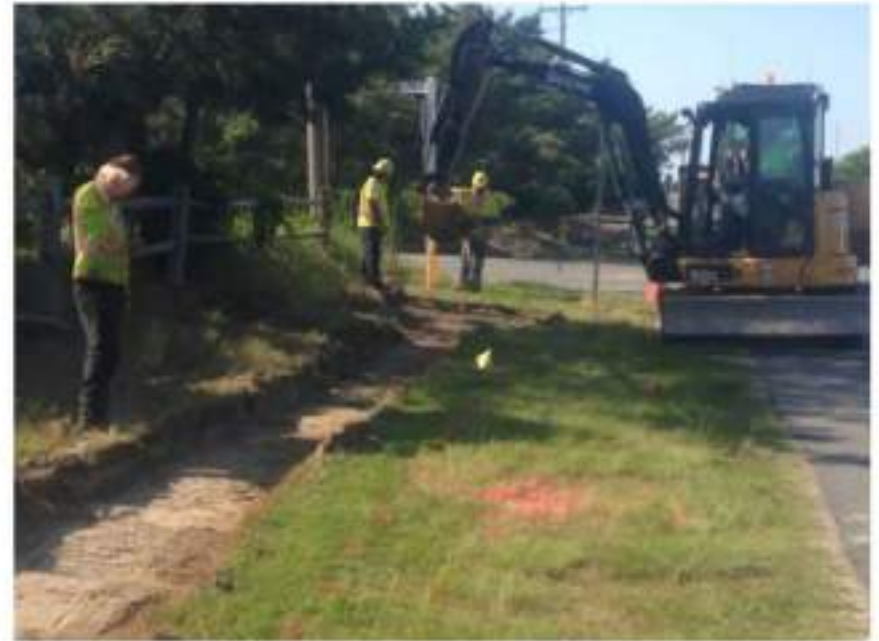
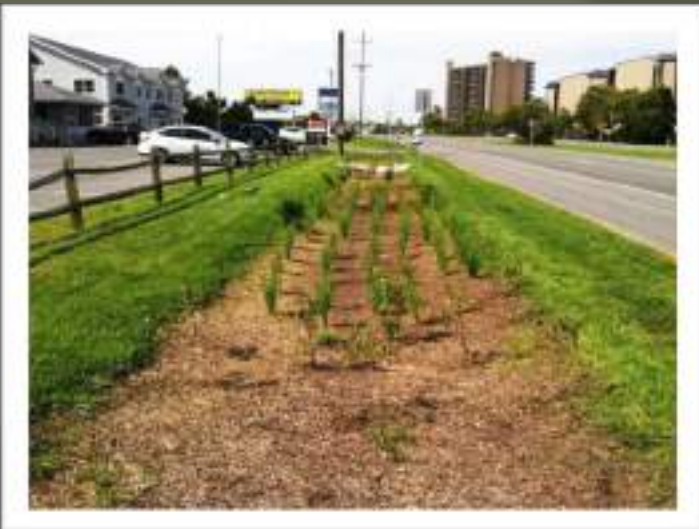
Right of Way Bioretention Areas

Six areas received bio-char amendment from 5 – 15%.

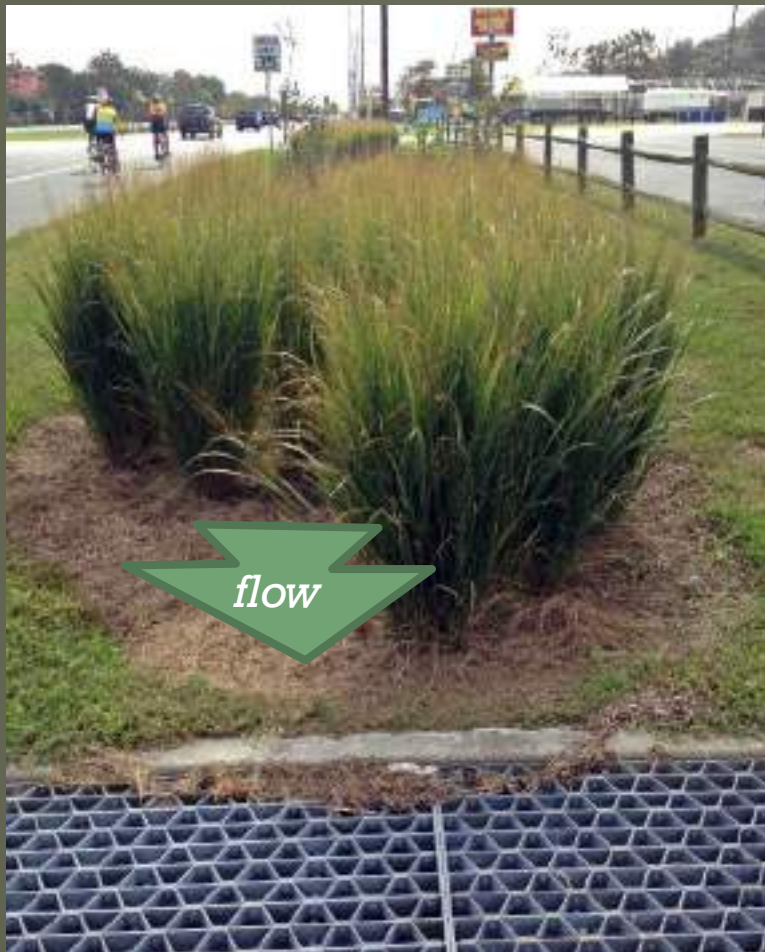
Highway Bioretention Performance

- Variable vegetation establishment and related sediment transport within areas
- Areas of bare, slightly eroding ground common
- Many established wetland conditions
- Typically drain within 48 hrs

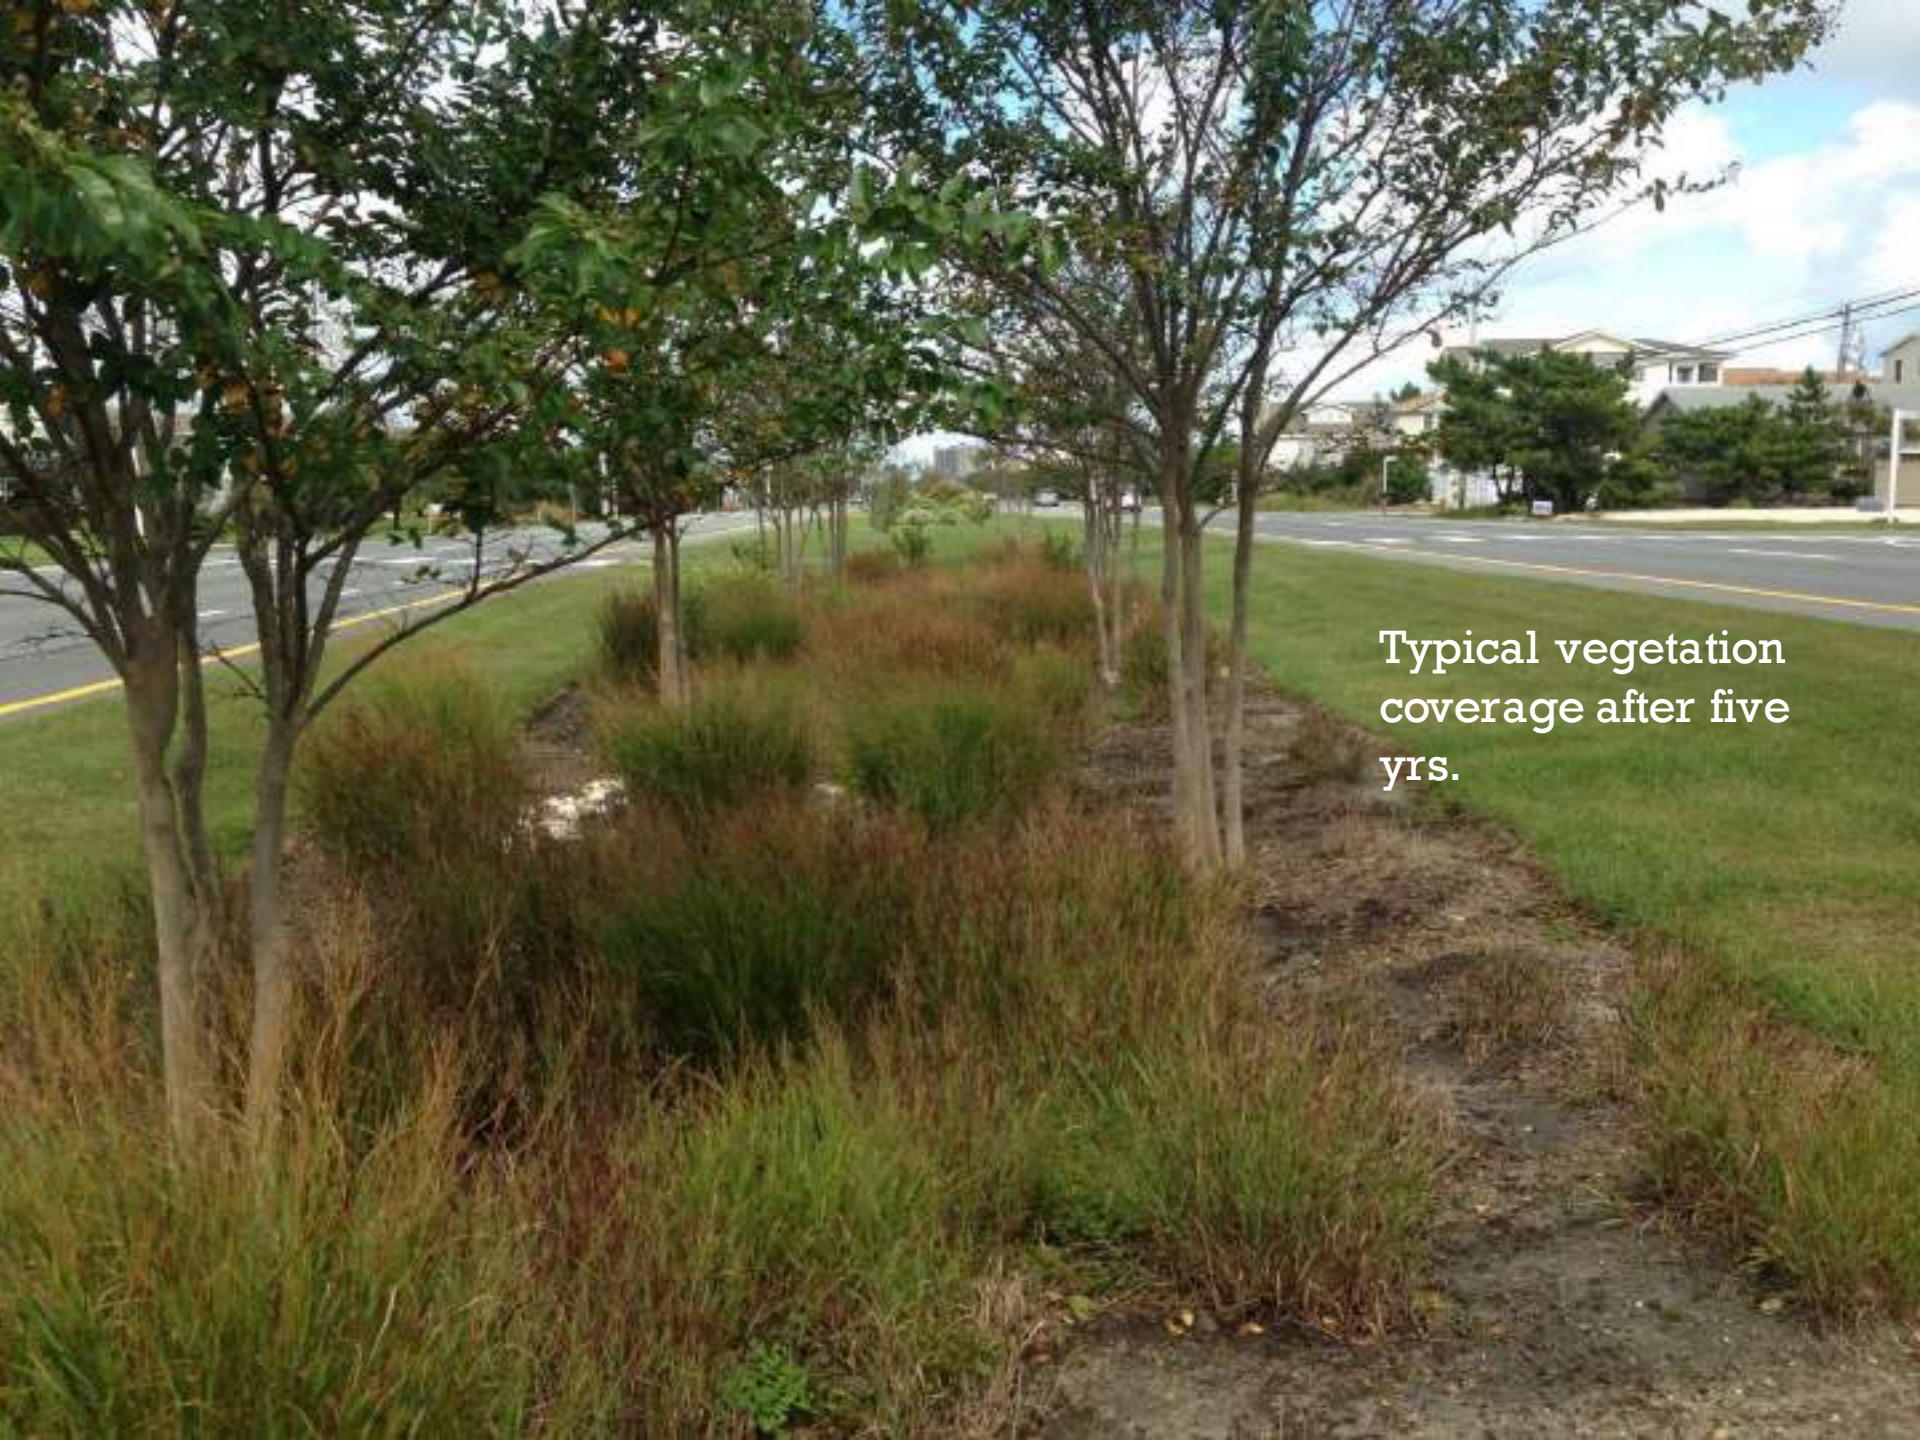
Typical vegetation
coverage after five
yrs.

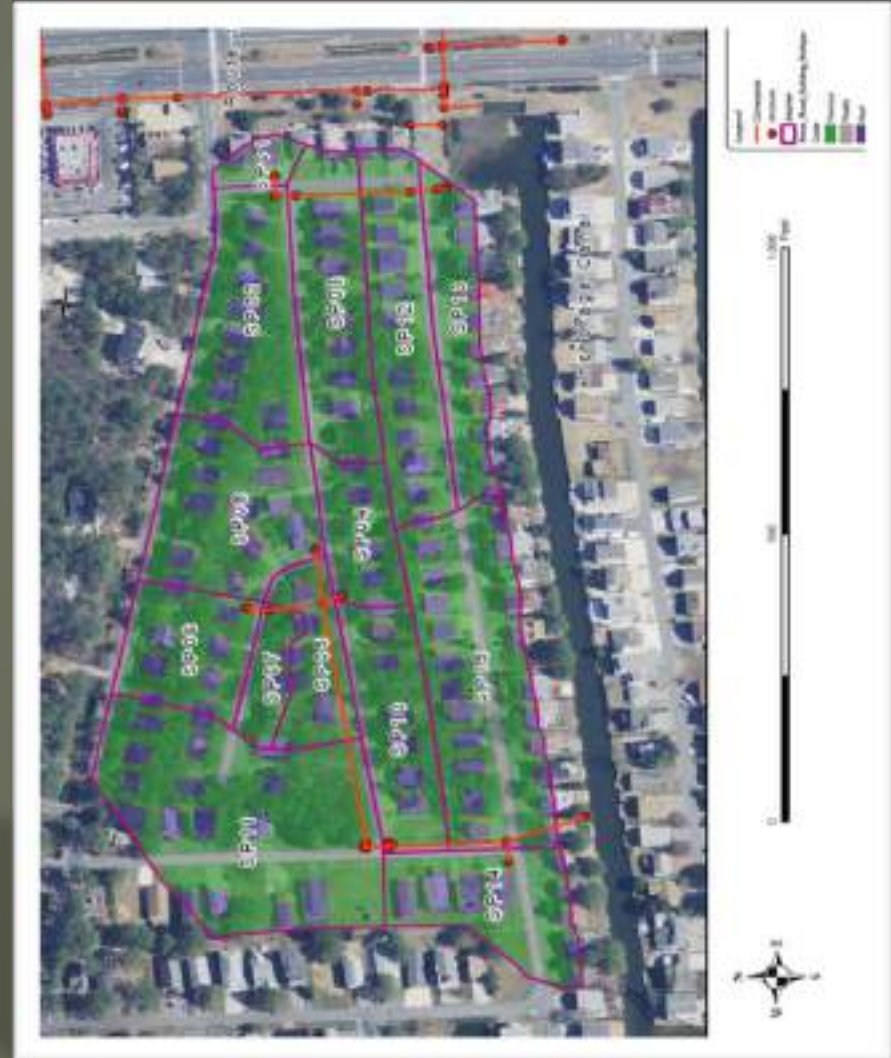
Project 4: Sandpiper Pines Bioretention and Infiltration Areas

- Concept design for 12 facilities around residential catch basins.
- Individual drainages mapped
- 6 in-situ bioretention /infiltration trenches and 2 infiltration trenches selected for implementation
- 10 total acres treated
 - 15 lbs nitrogen removed
 - 2 lbs phosphorus removed
 - 452 lbs sediment removed

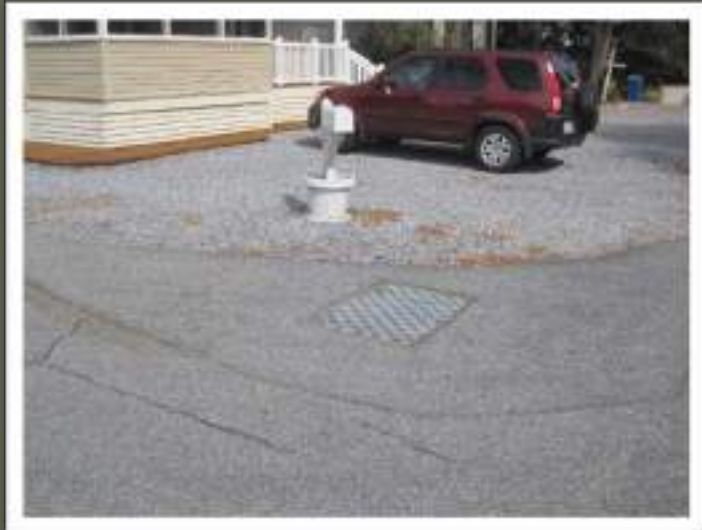
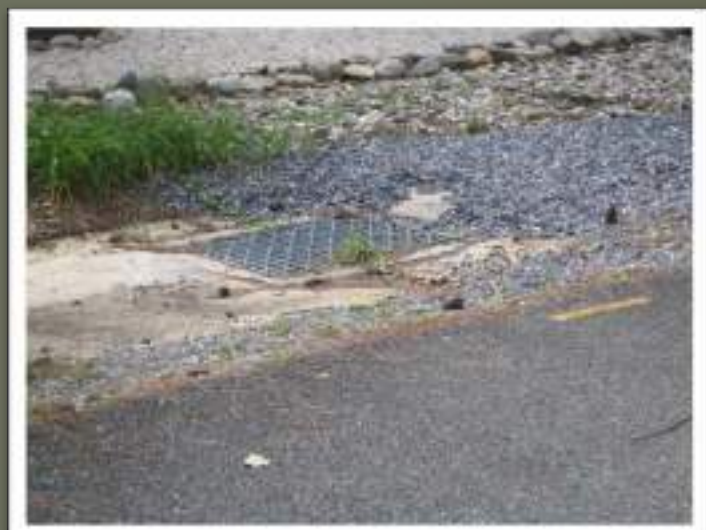
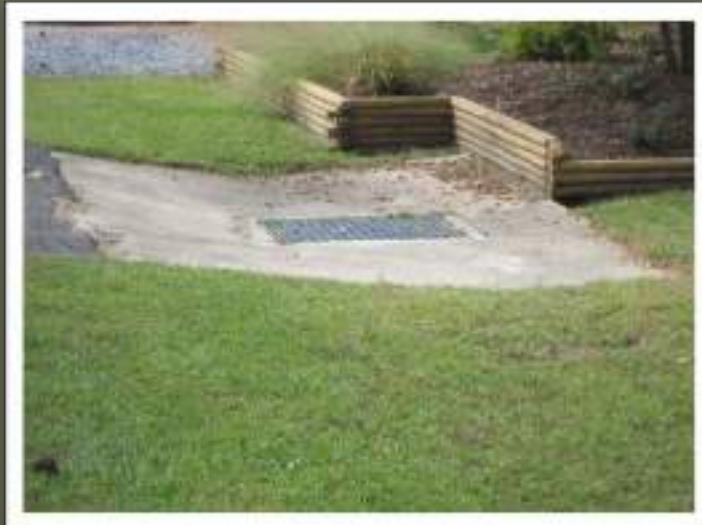
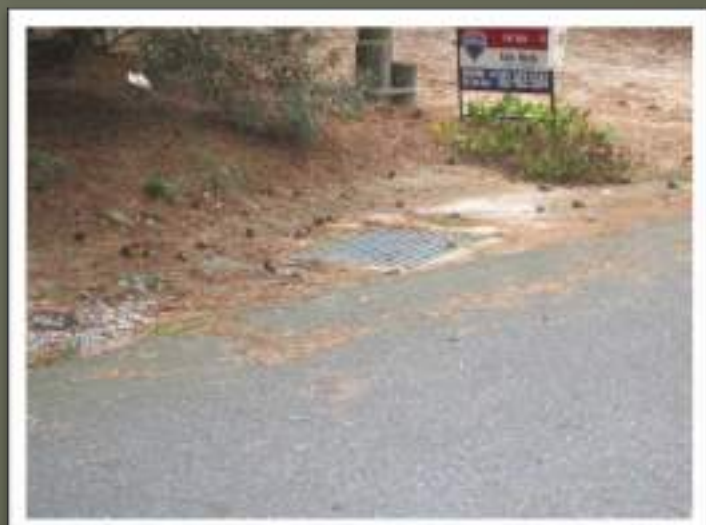
Sandpiper Pines Pre-existing Conditions

Infiltration
trench/bioretention area
completed: 2016.

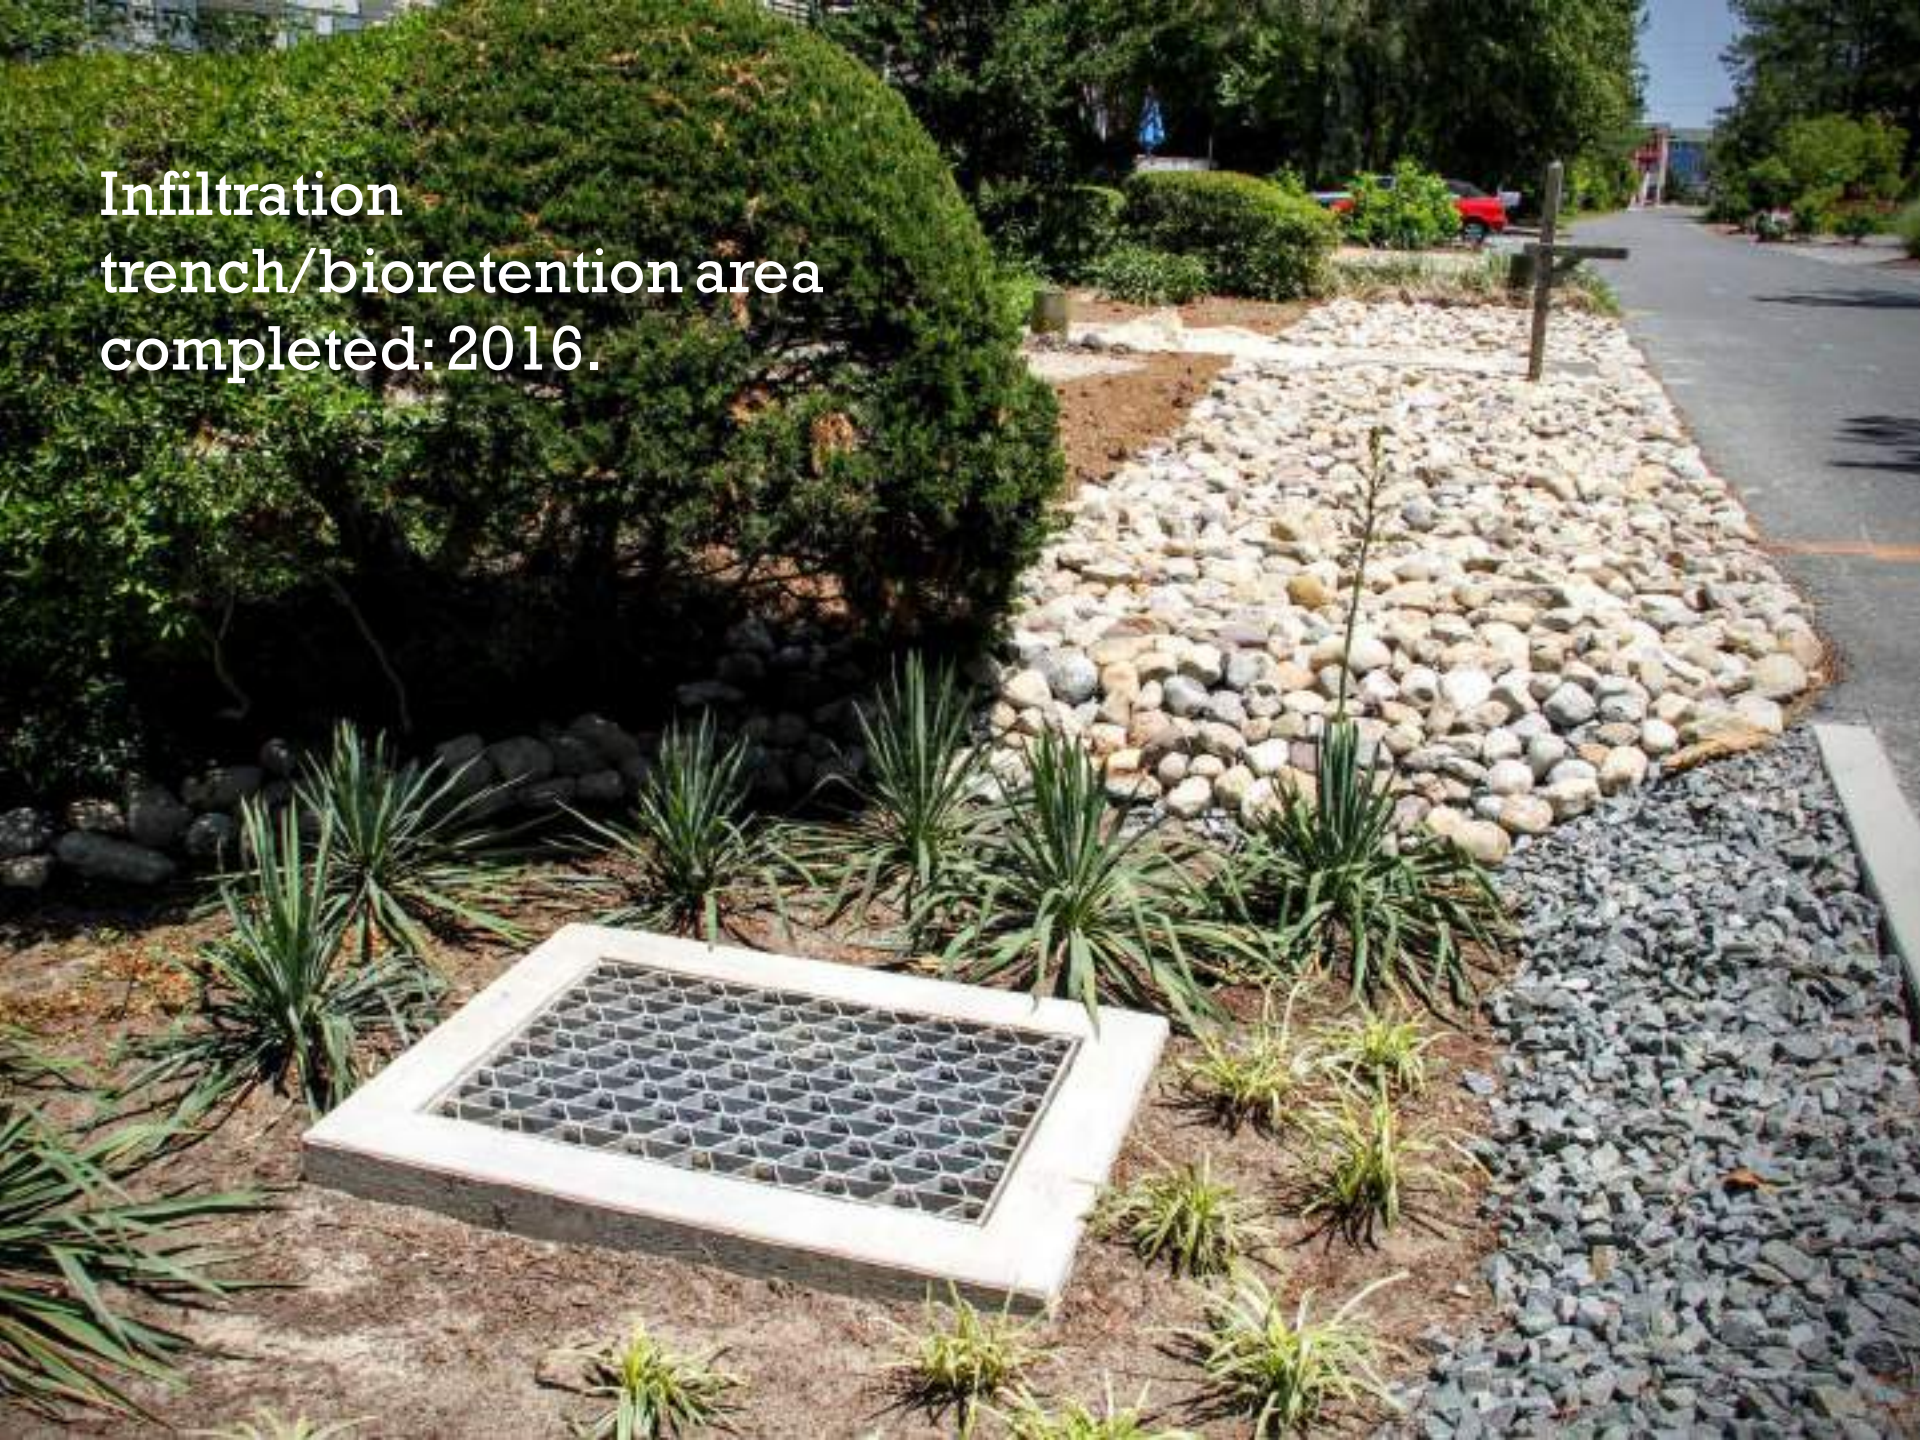
Catch basin

Infiltration
trench/bioretention area
completed: 2016.
