The Anchorage Canal Drainage Area Stormwater Retrofit Project

Chris Bason & Dr. Marianne Walch, *Delaware Center for
the Inland Bays*

*Presentation to CIB Board of Directors
December 15, 2017*

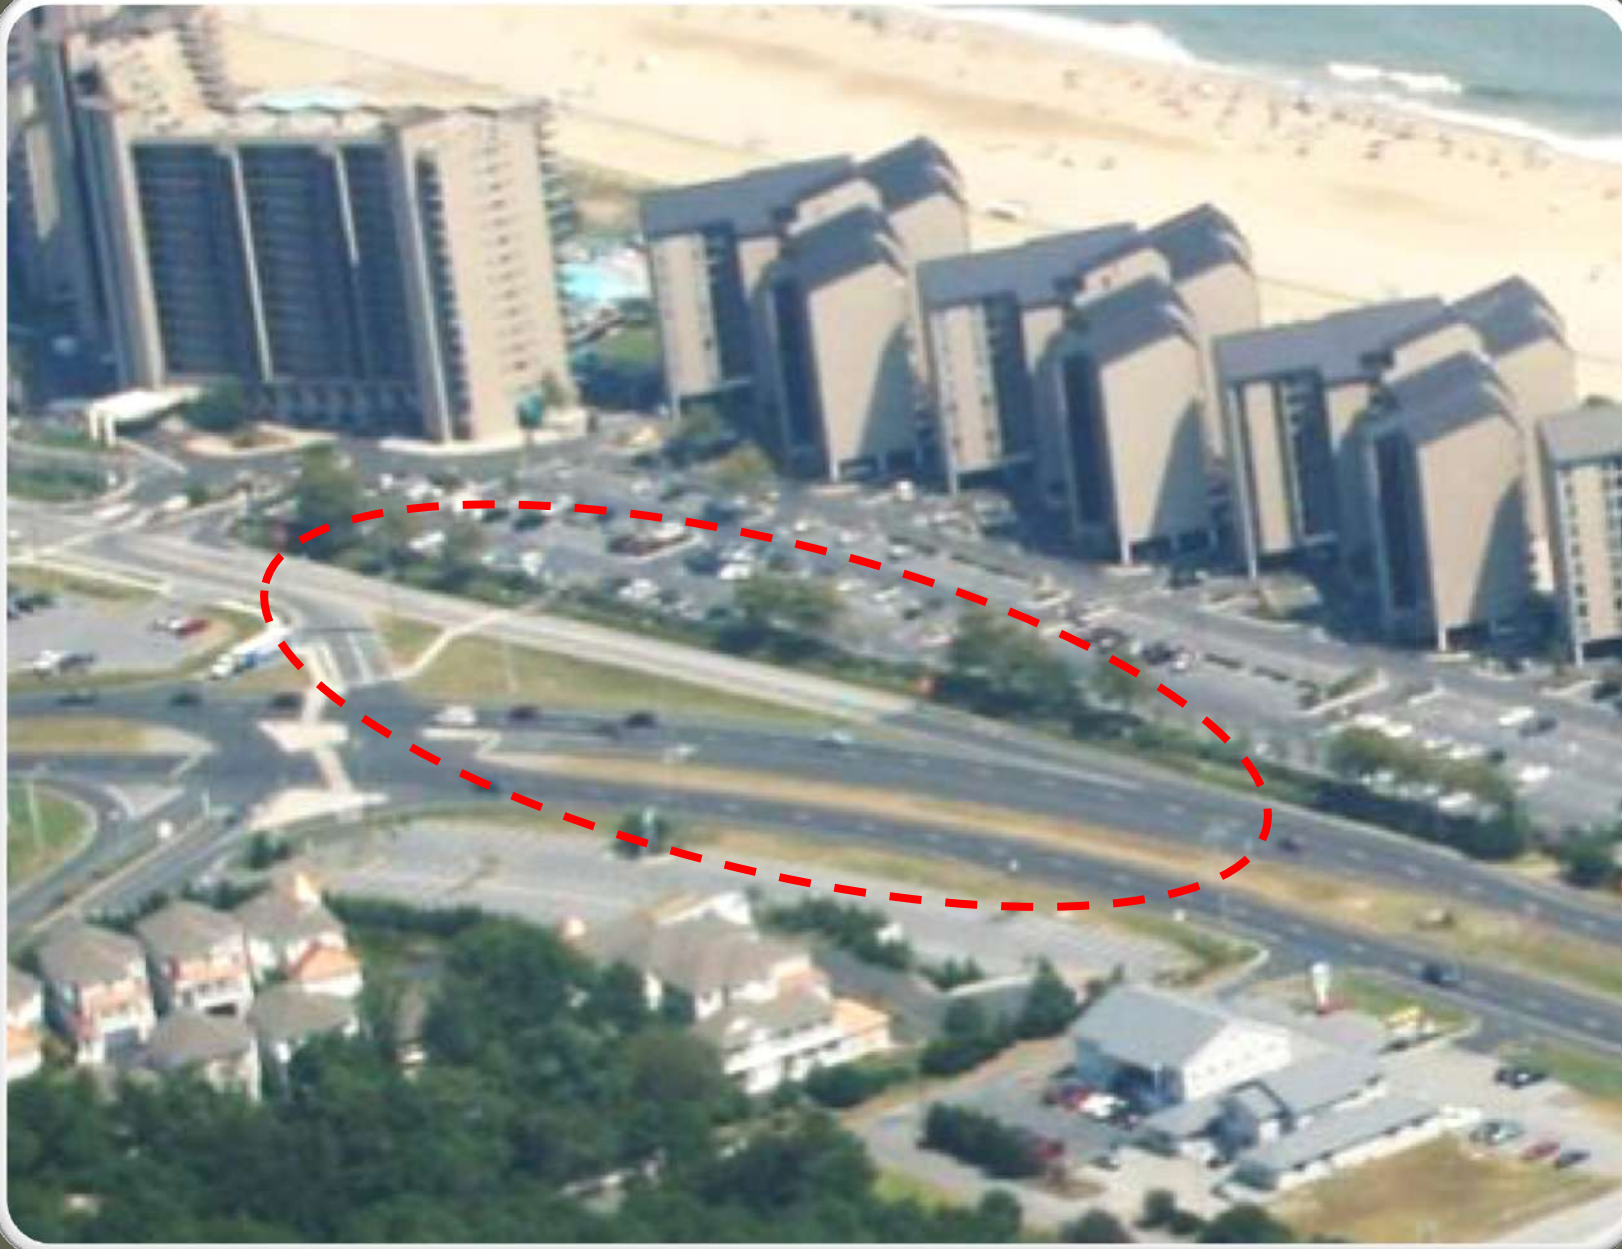
Wetland – Wetpond Demo
Project Location Aerial

‘Slip-ramp’ highly used during summer by pedestrian and bicyclists that conflict with sometimes speeding autos.

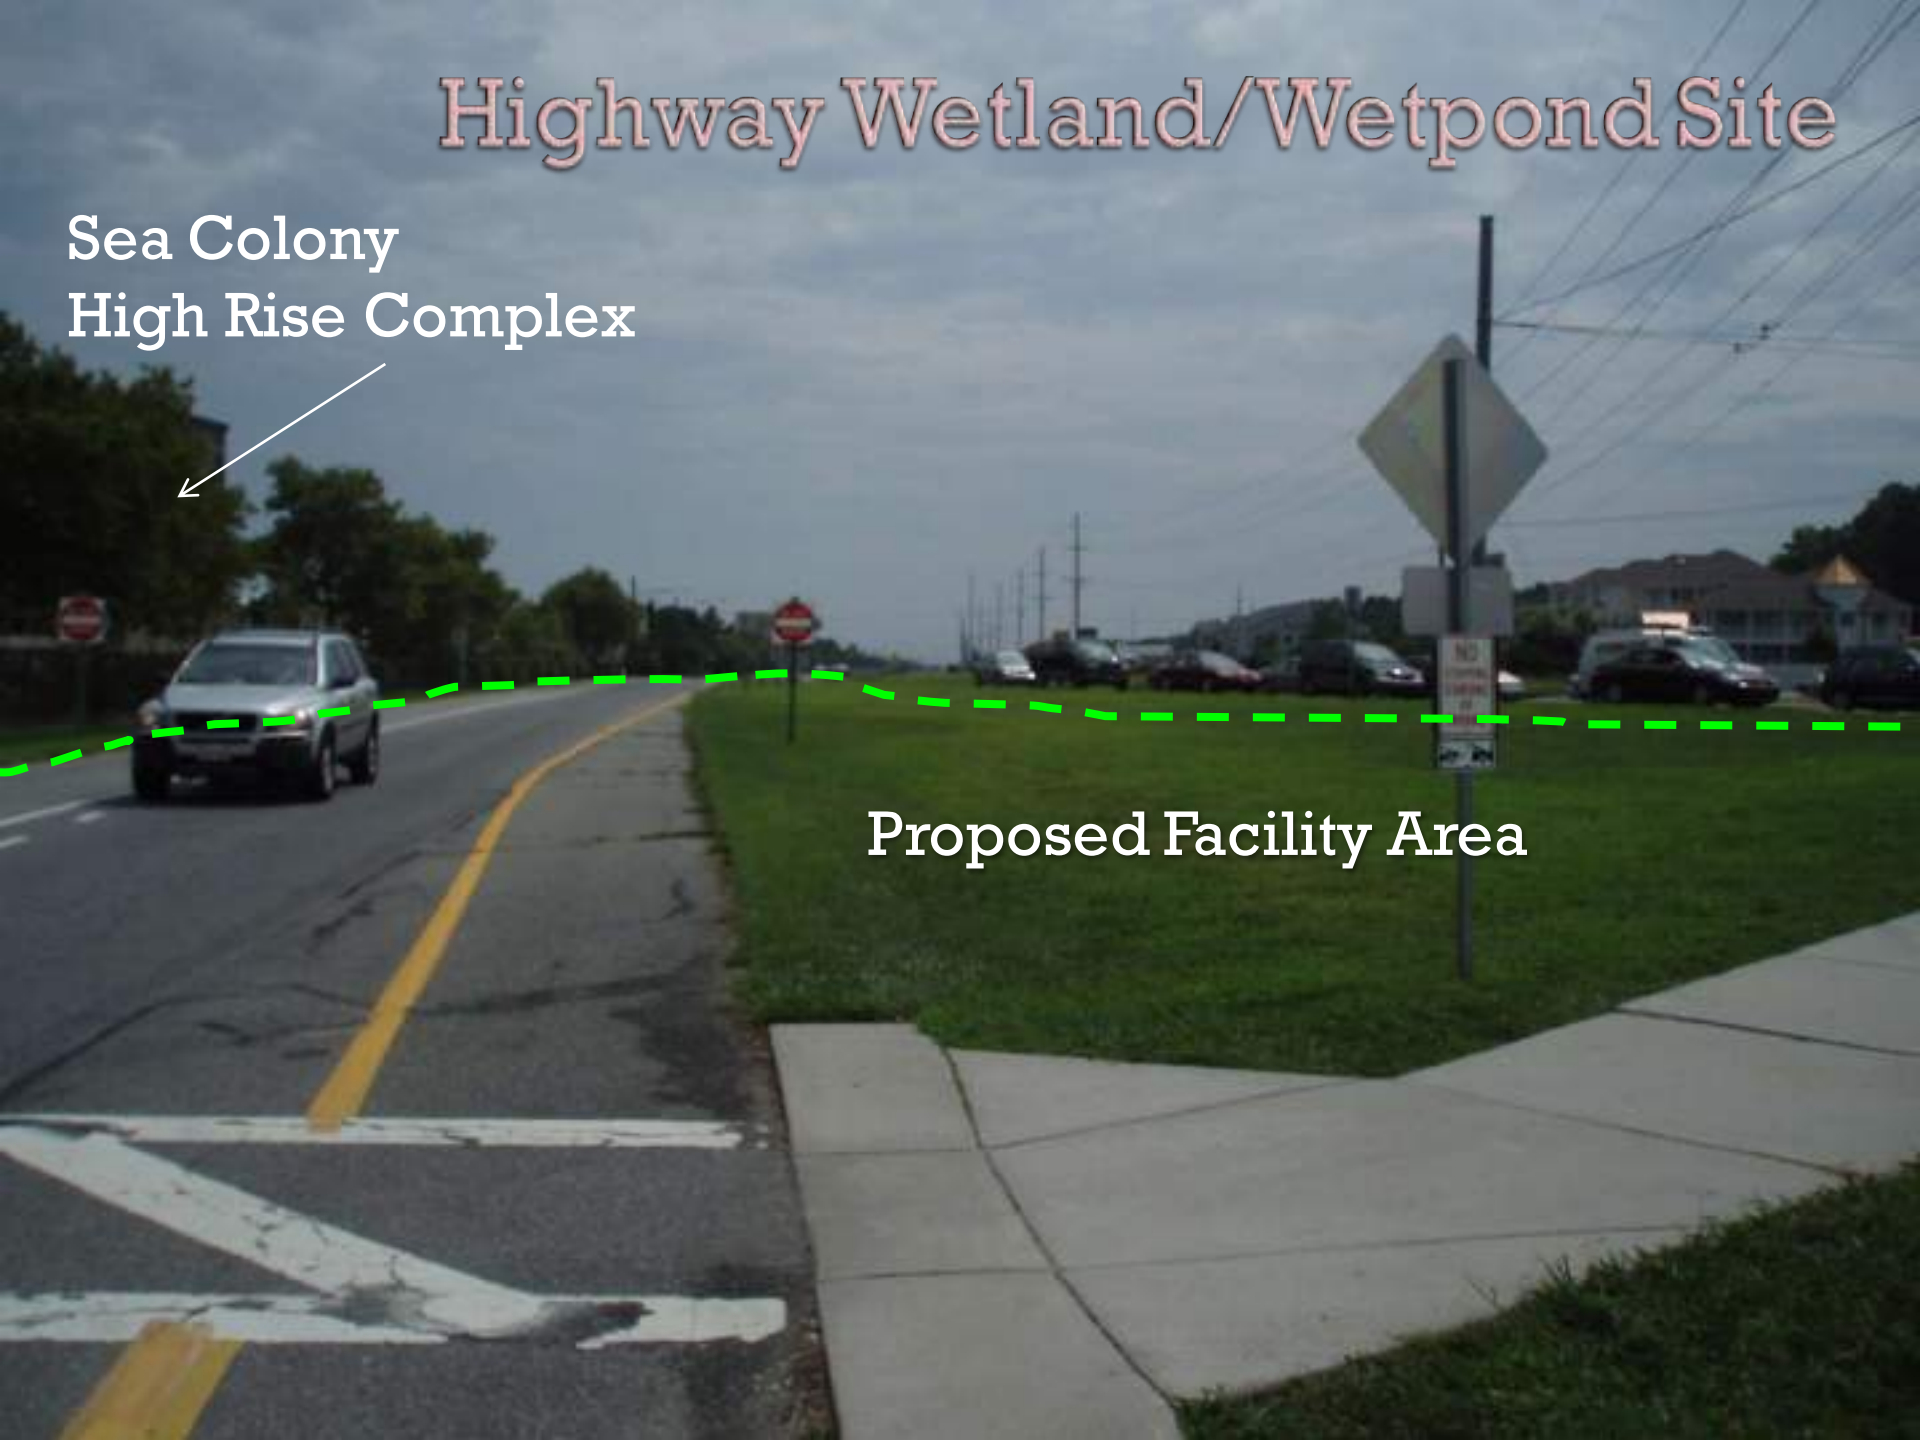
Continuing Projects: Highway Wetland/Wetpond

- Treat 6.4 acres of high rise complex runoff.
- Part of existing treatment train
- Estimated removal of 25.6 lbs. of nitrogen and 4.6 lbs. of phosphorus
- Estimated cost of \$500,000 funded 80% by DelDOT and 20% by SeaColony and CIB
