HYDROACOUSTIC MONITORING OF SUBMERGED AQUATIC VEGETATION IN THE DELAWARE ESTUARY

Presenter: Kristin Regan, EPA Region 3, Office of Monitoring and Assessment

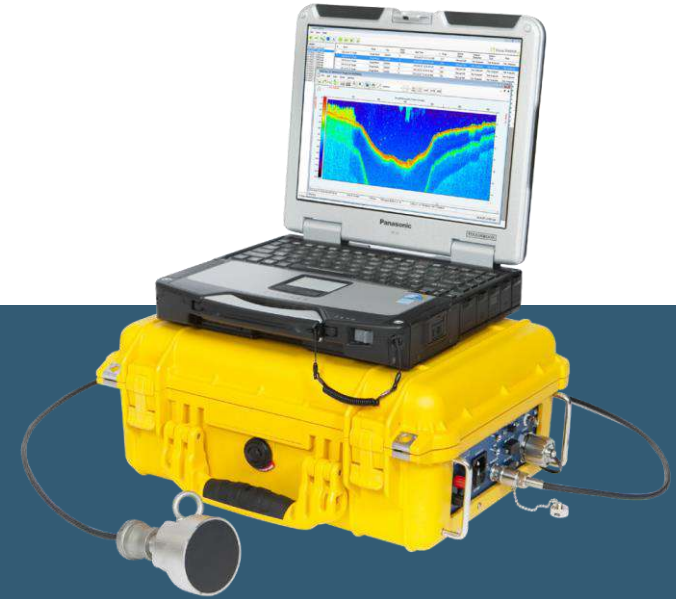
- Hydroacoustic SAV monitoring
 - BioSonics MX Habitat Echosounder
 - BioSonics Visual Acquisition Software for post-processing
 - BioSonics Visual Habitat Software for data analysis
- Underwater Camera and Dive Team
 - Selected Ground Truthing/Survey of Benthics

Image taken from <http://www.biosonicsinc.com/products/mx-aquatic-habitat-echosounder/>

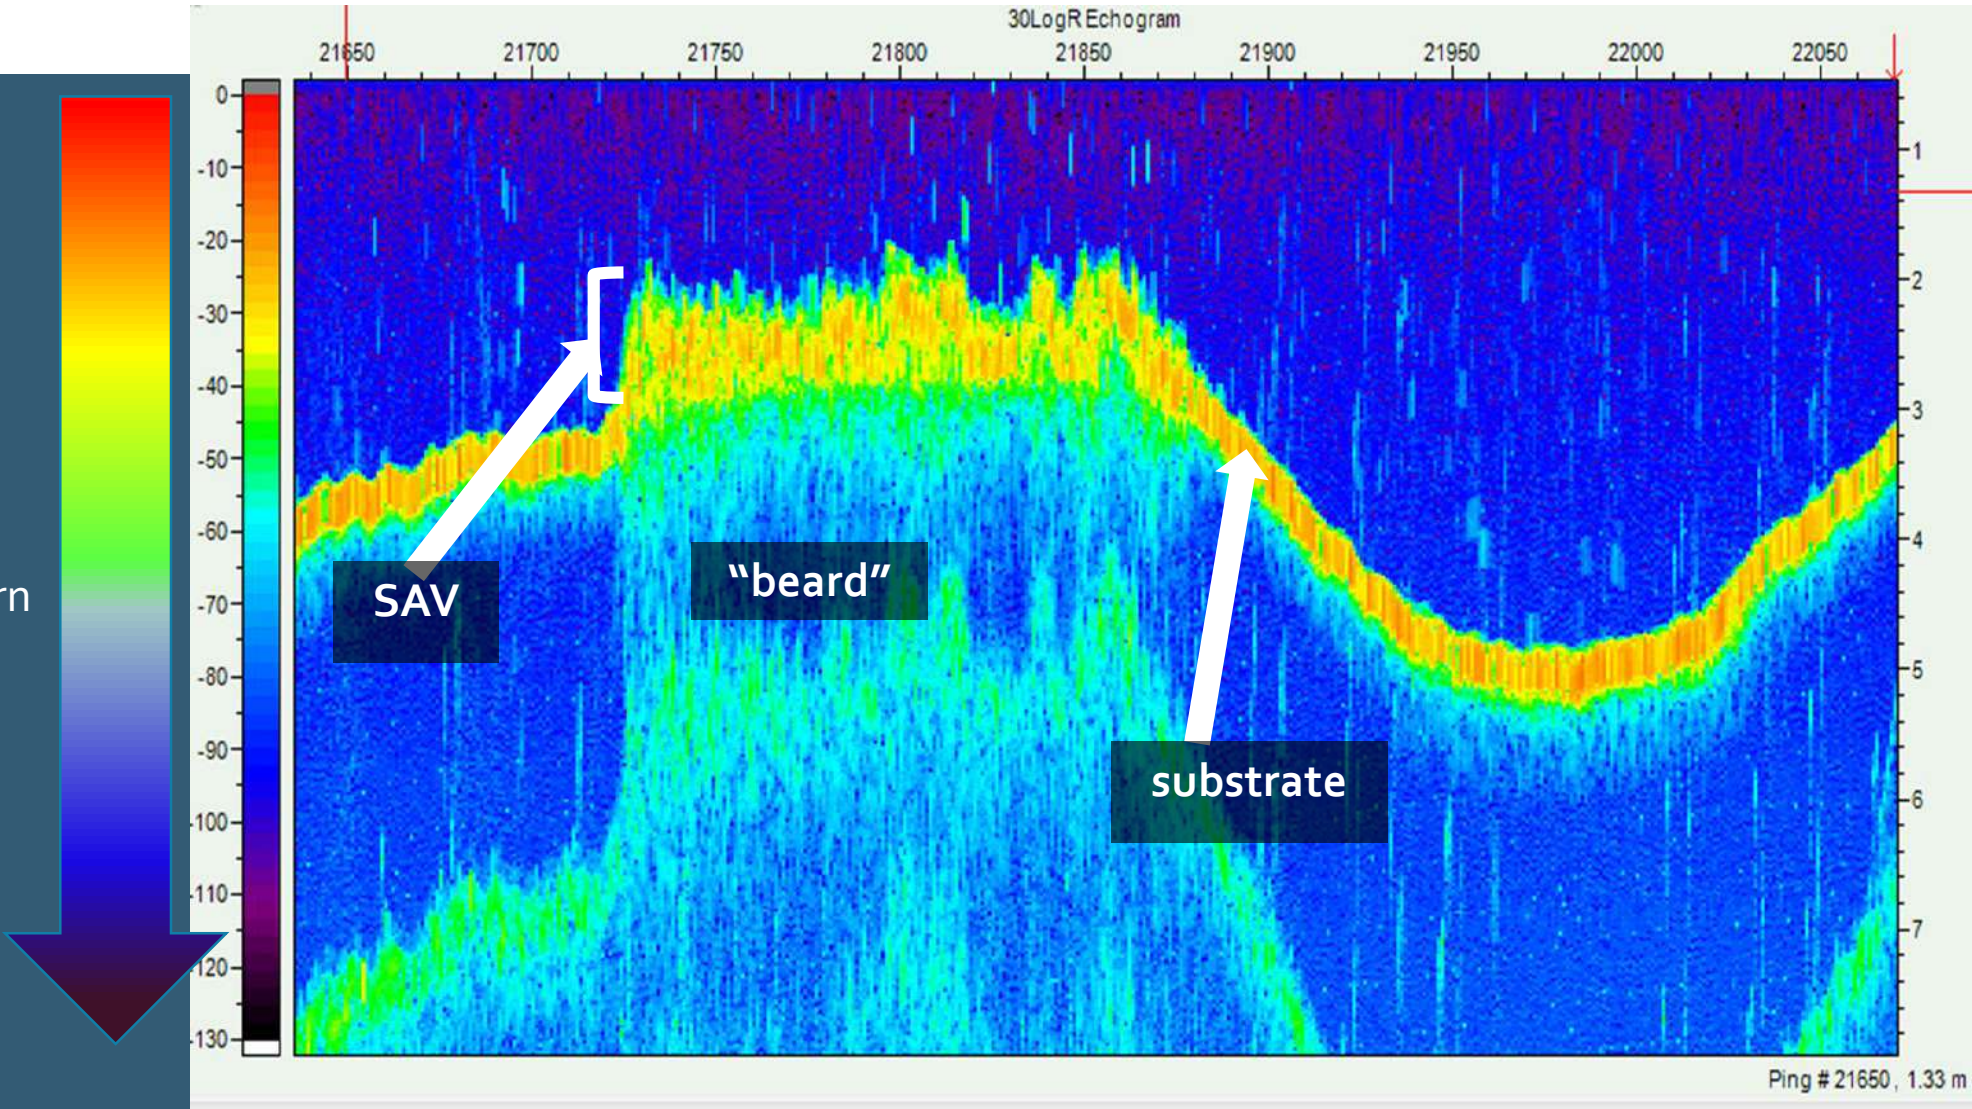
GETTING 'SAV'VY

Amplitude (dB)
Red: strong return echo

Green: SAV signature return

Blue: weak return echo

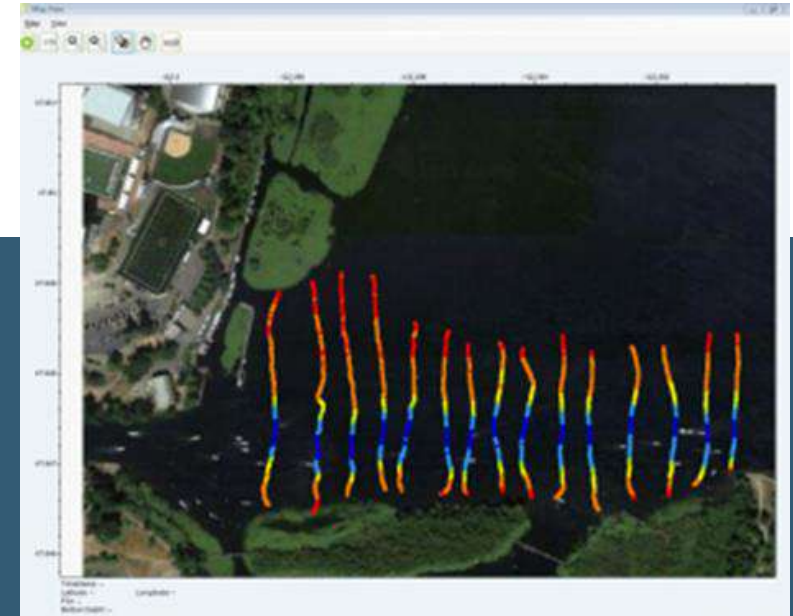
- Parallel transect to shore at 10ft MHHW to determine presence/absence
- Perpendicular transects where SAV is present
 - Delineate SAV bed
- Divers ground truthed transects of SAV beds

Image taken from <http://www.biosonicsinc.com/products/mx-aquatic-habitat-echosounder/>

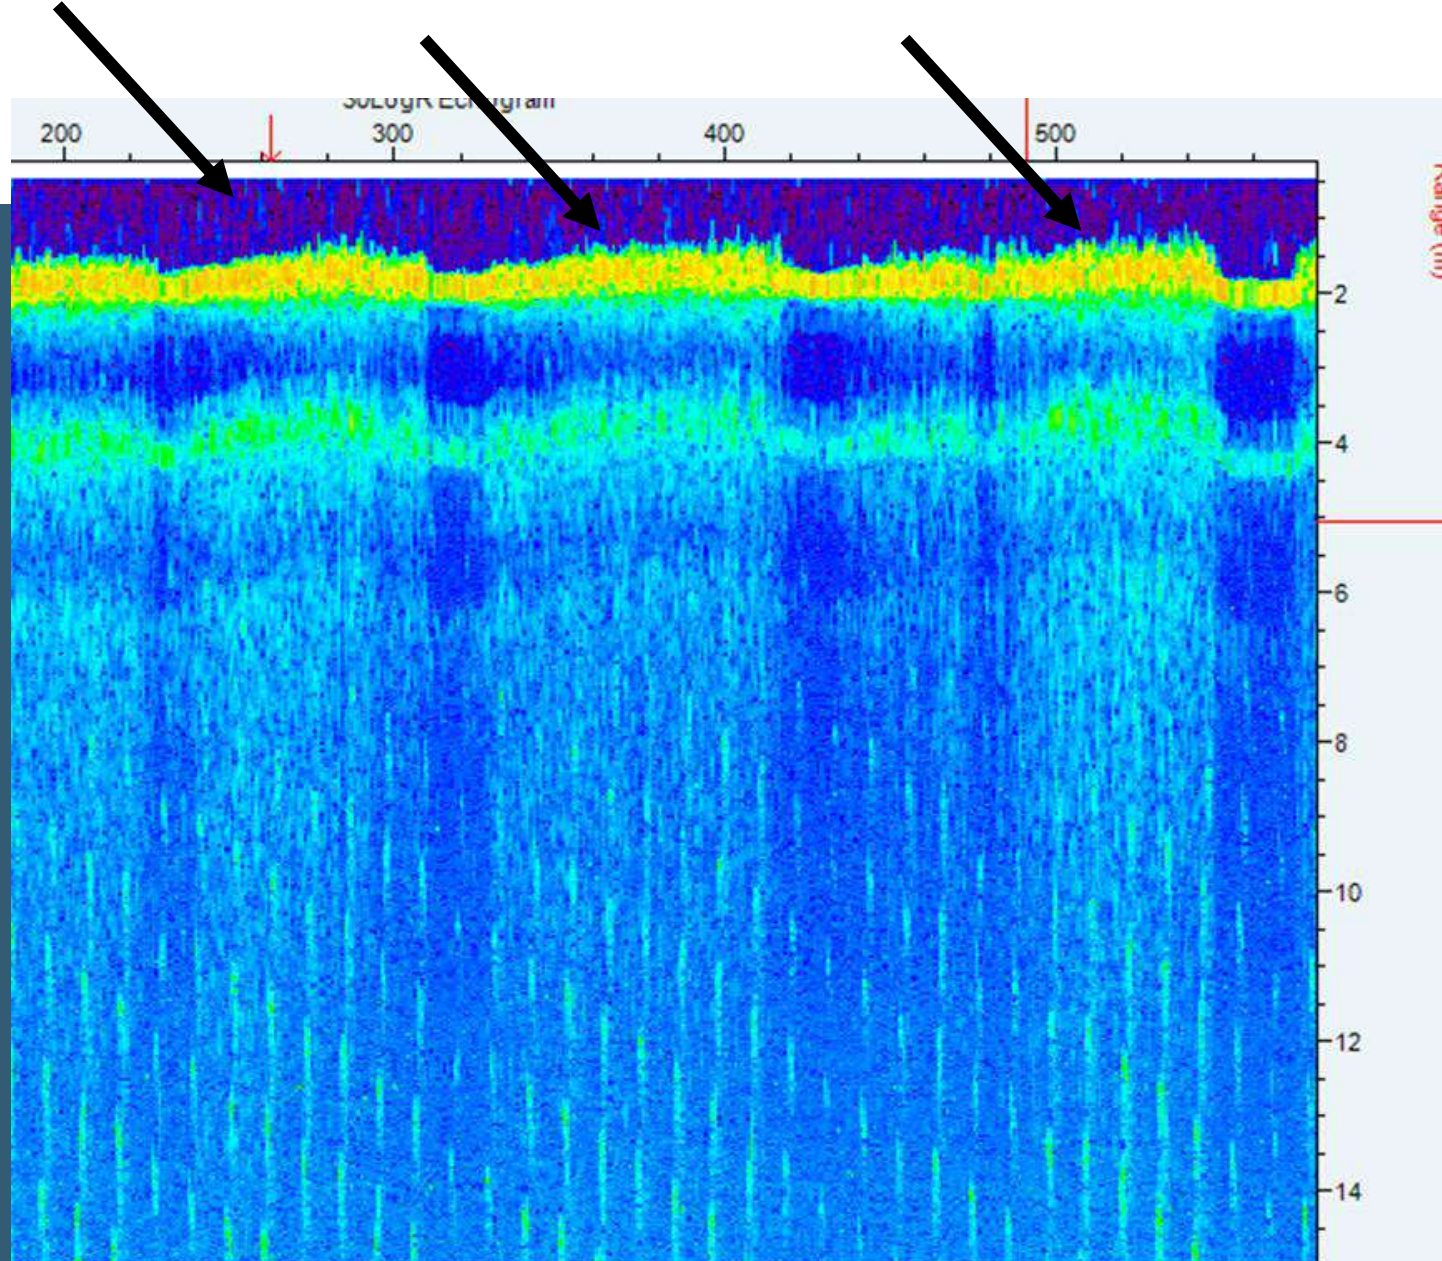
- We found SAV!
- This echogram indicates SAV is found along this transect.
 - We then rake for species identification and confirmation

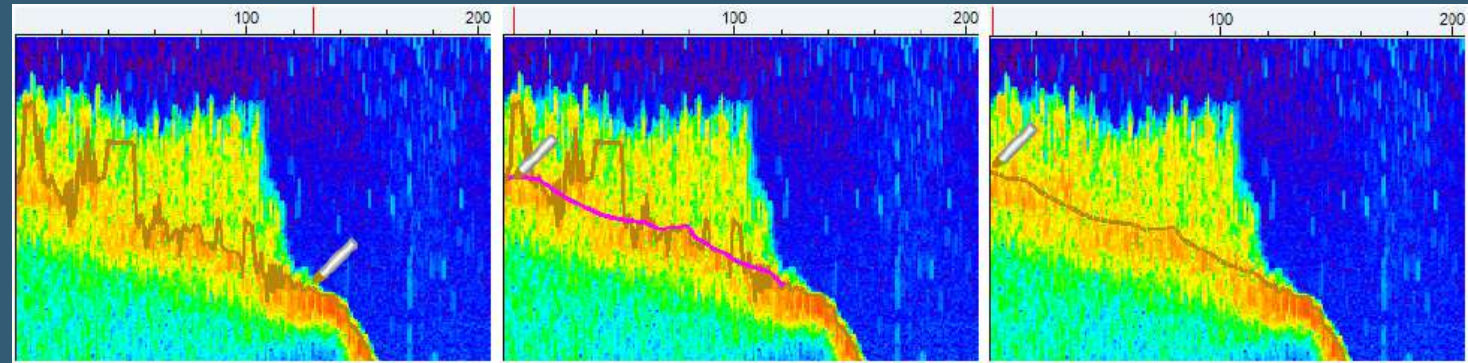
Images taken from BioSonics Visual Habitat User Guide.
