2022 State of the Delaware Inland Bays

ORGANIZATION OF THE REPORT

40 environmental indicators, grouped into six chapters

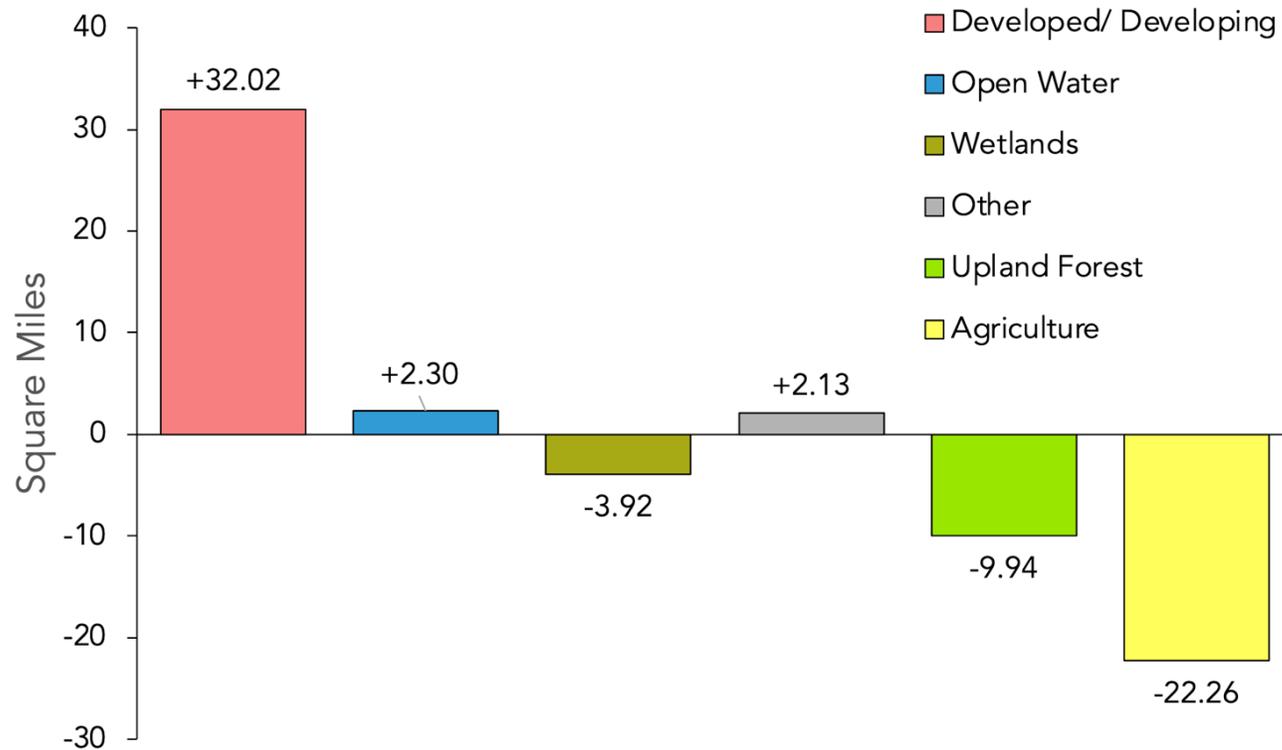
Land Use Change

Changes in Land Use from 1992 to 2017

- 18% loss in forest
- 6% loss in wetlands
- 19% loss in agriculture
- 78% increase in development

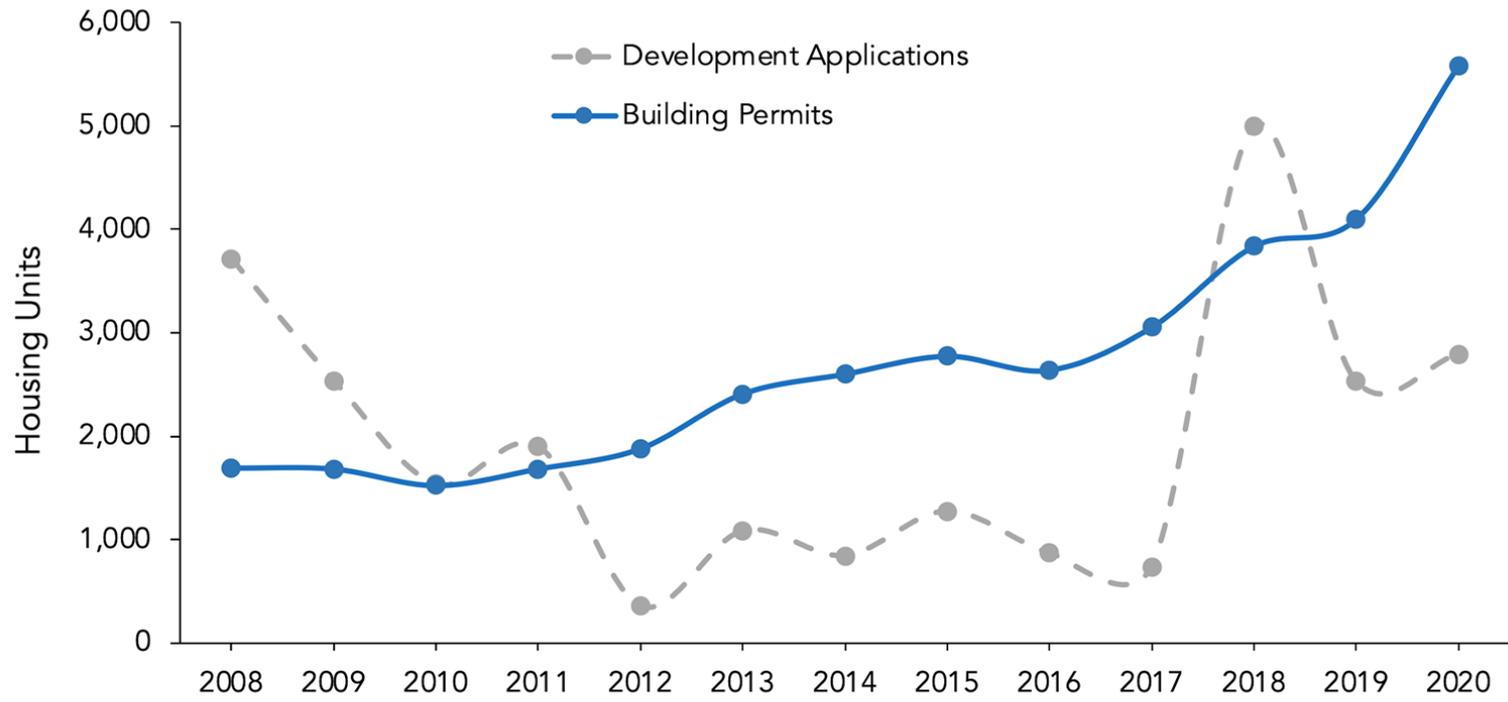
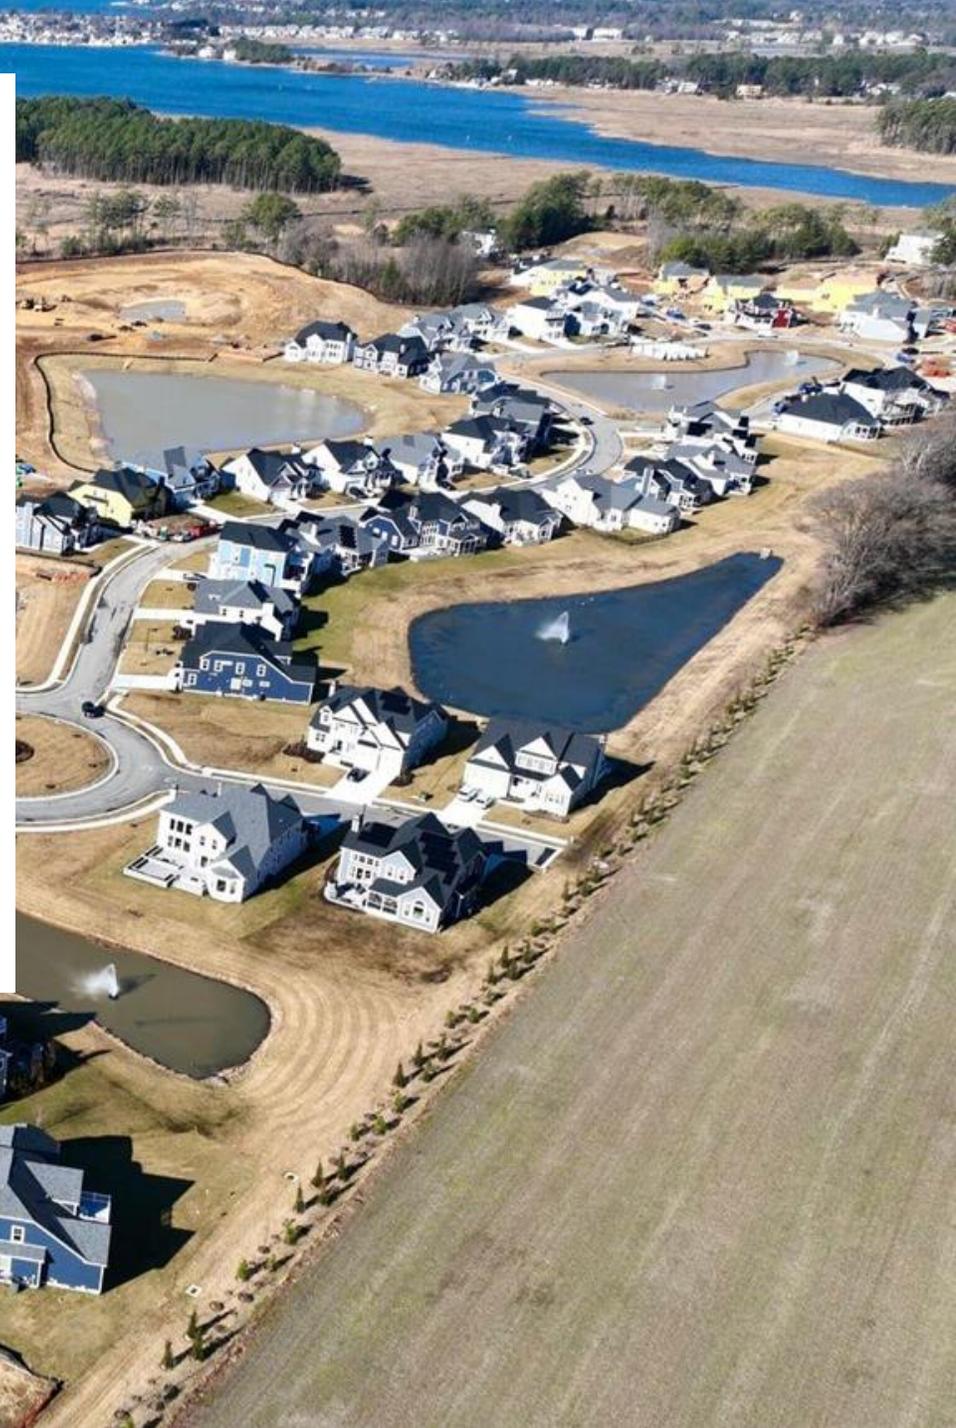
Number of Residential Units in Sussex County Development Applications and Building Permits

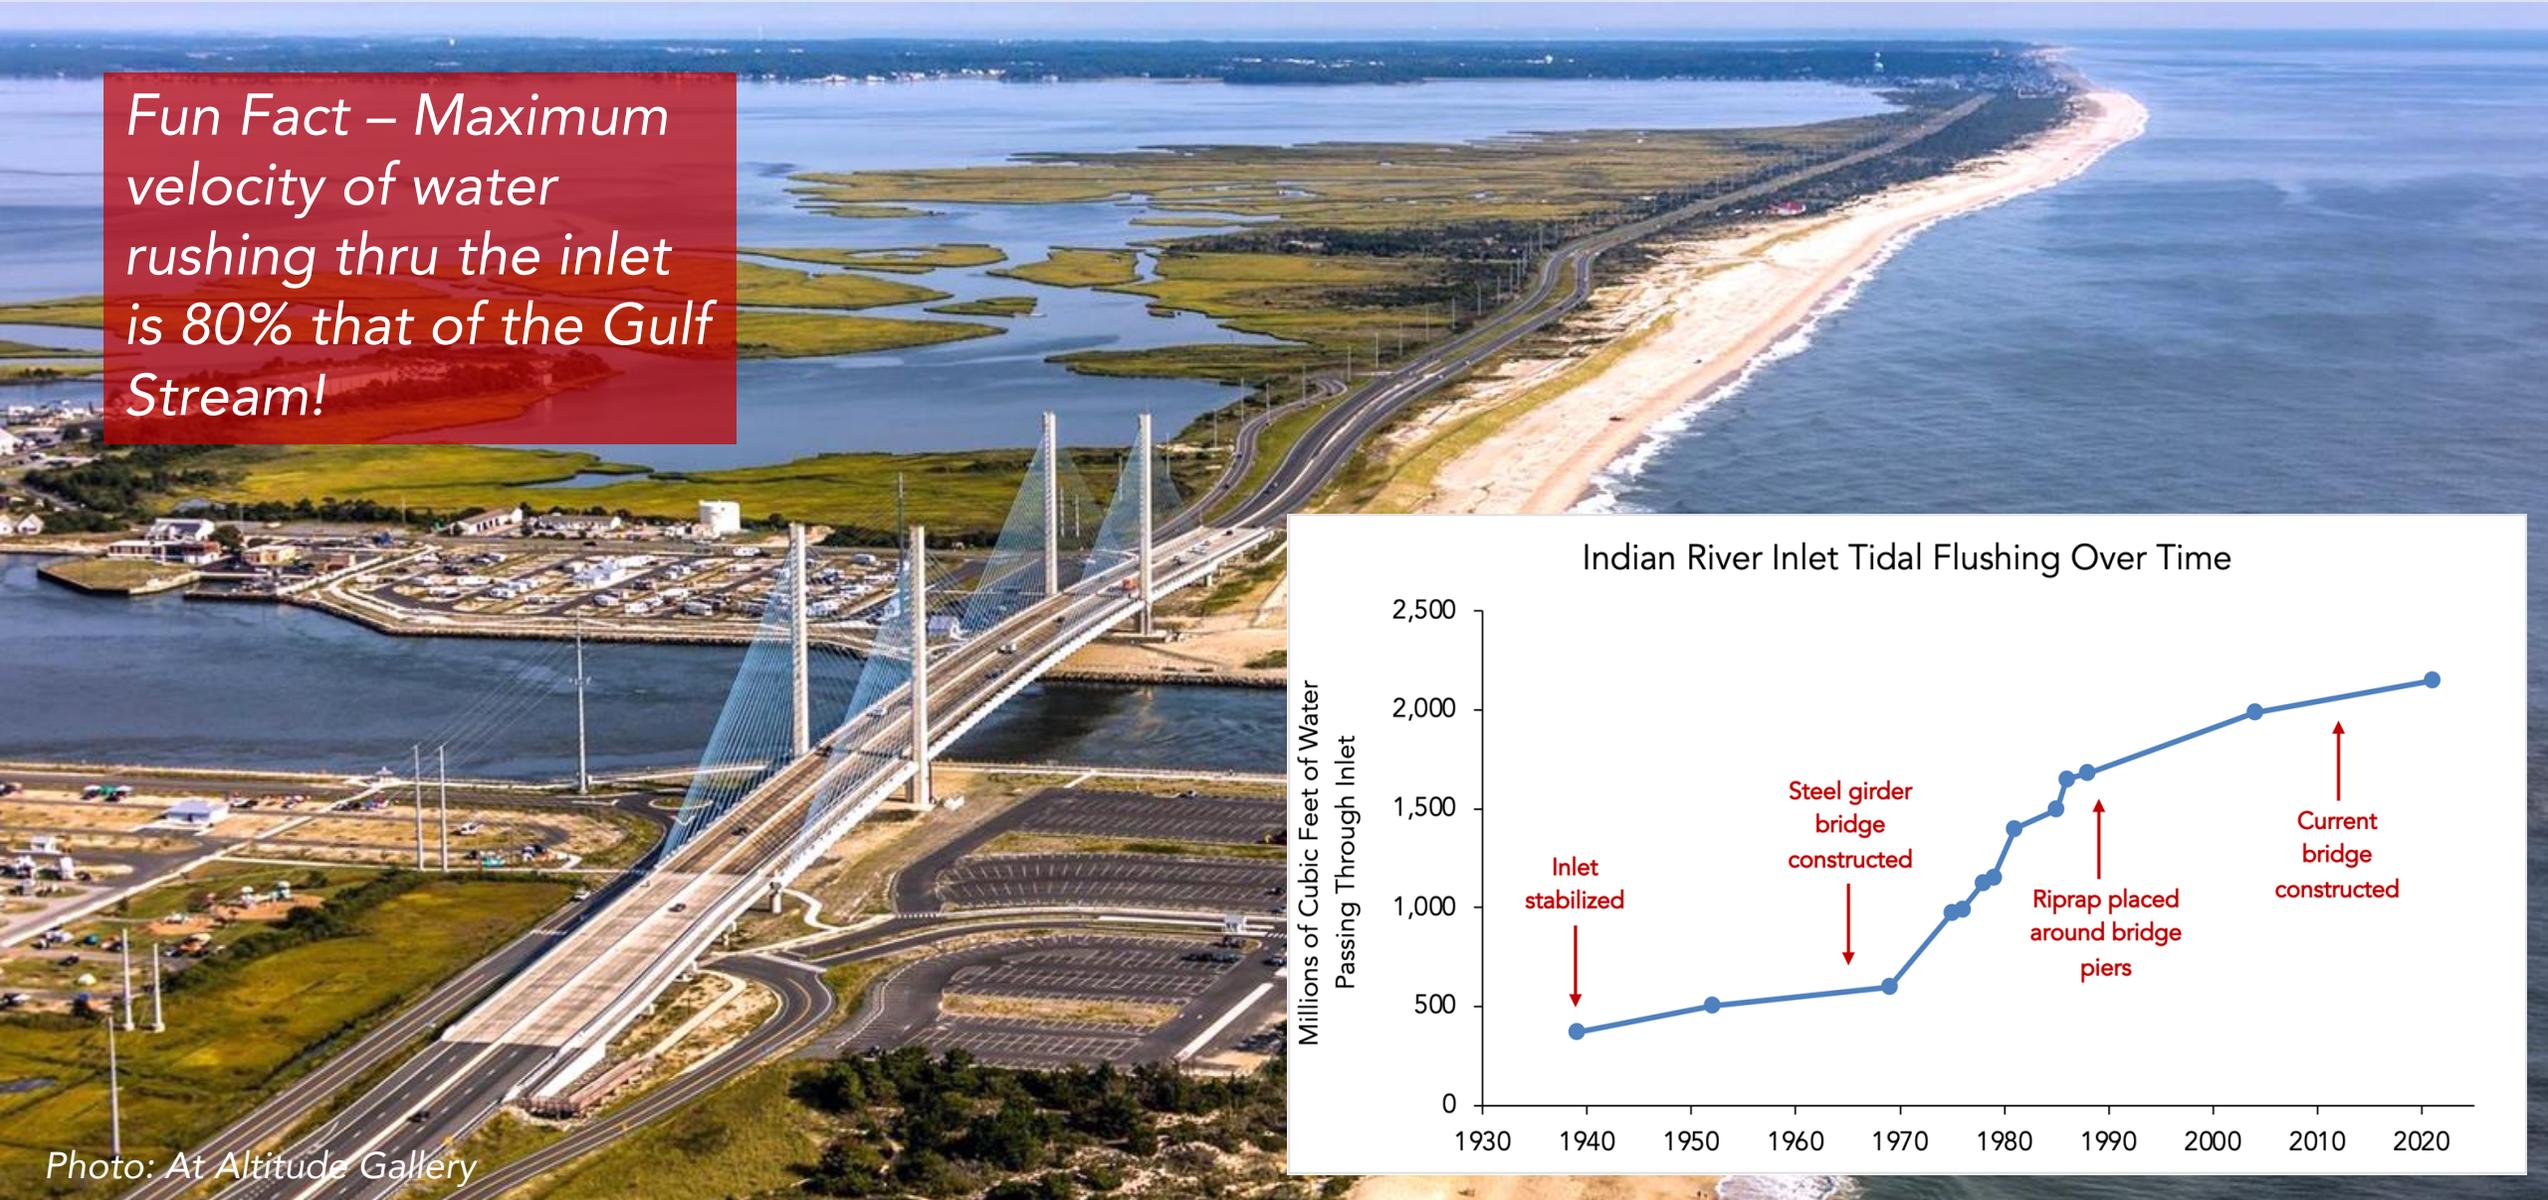
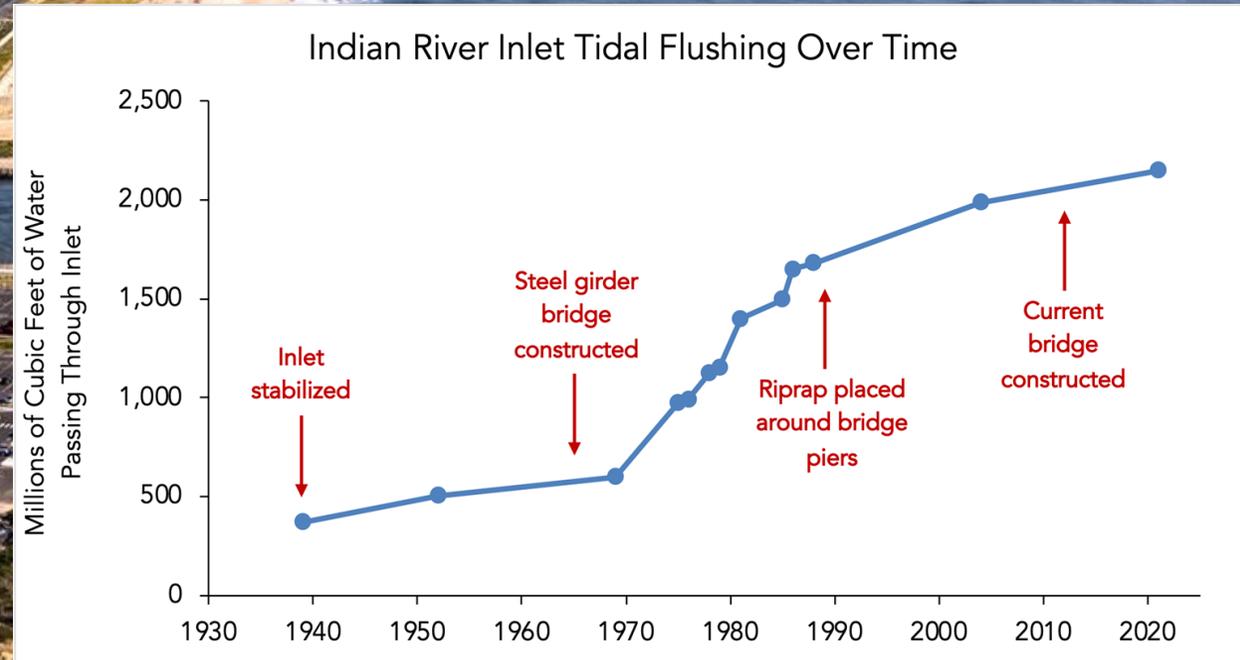
Indian River Inlet Flushing

Fun Fact – Maximum velocity of water rushing thru the inlet is 80% that of the Gulf Stream!

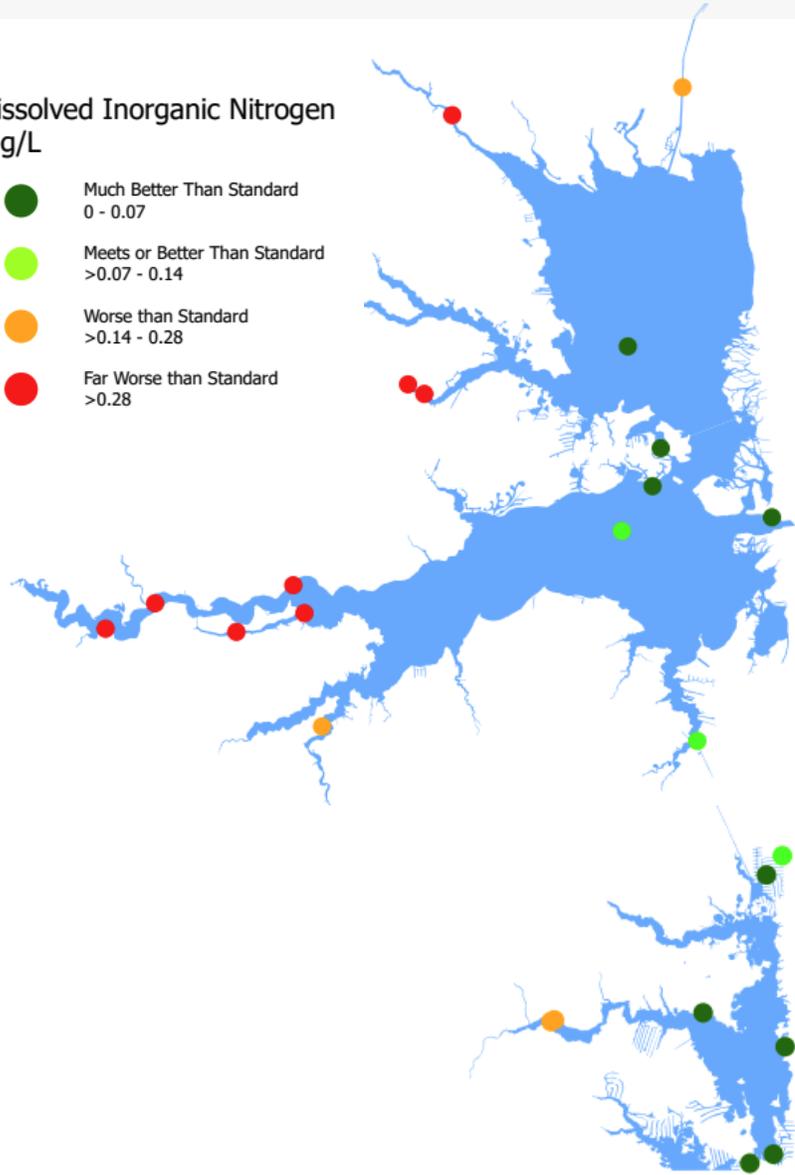
Concentrations of Nitrogen

Dissolved Inorganic Nitrogen
mg/L

- Much Better Than Standard
0 - 0.07
- Meets or Better Than Standard
>0.07 - 0.14
- Worse than Standard
>0.14 - 0.28
- Far Worse than Standard
>0.28

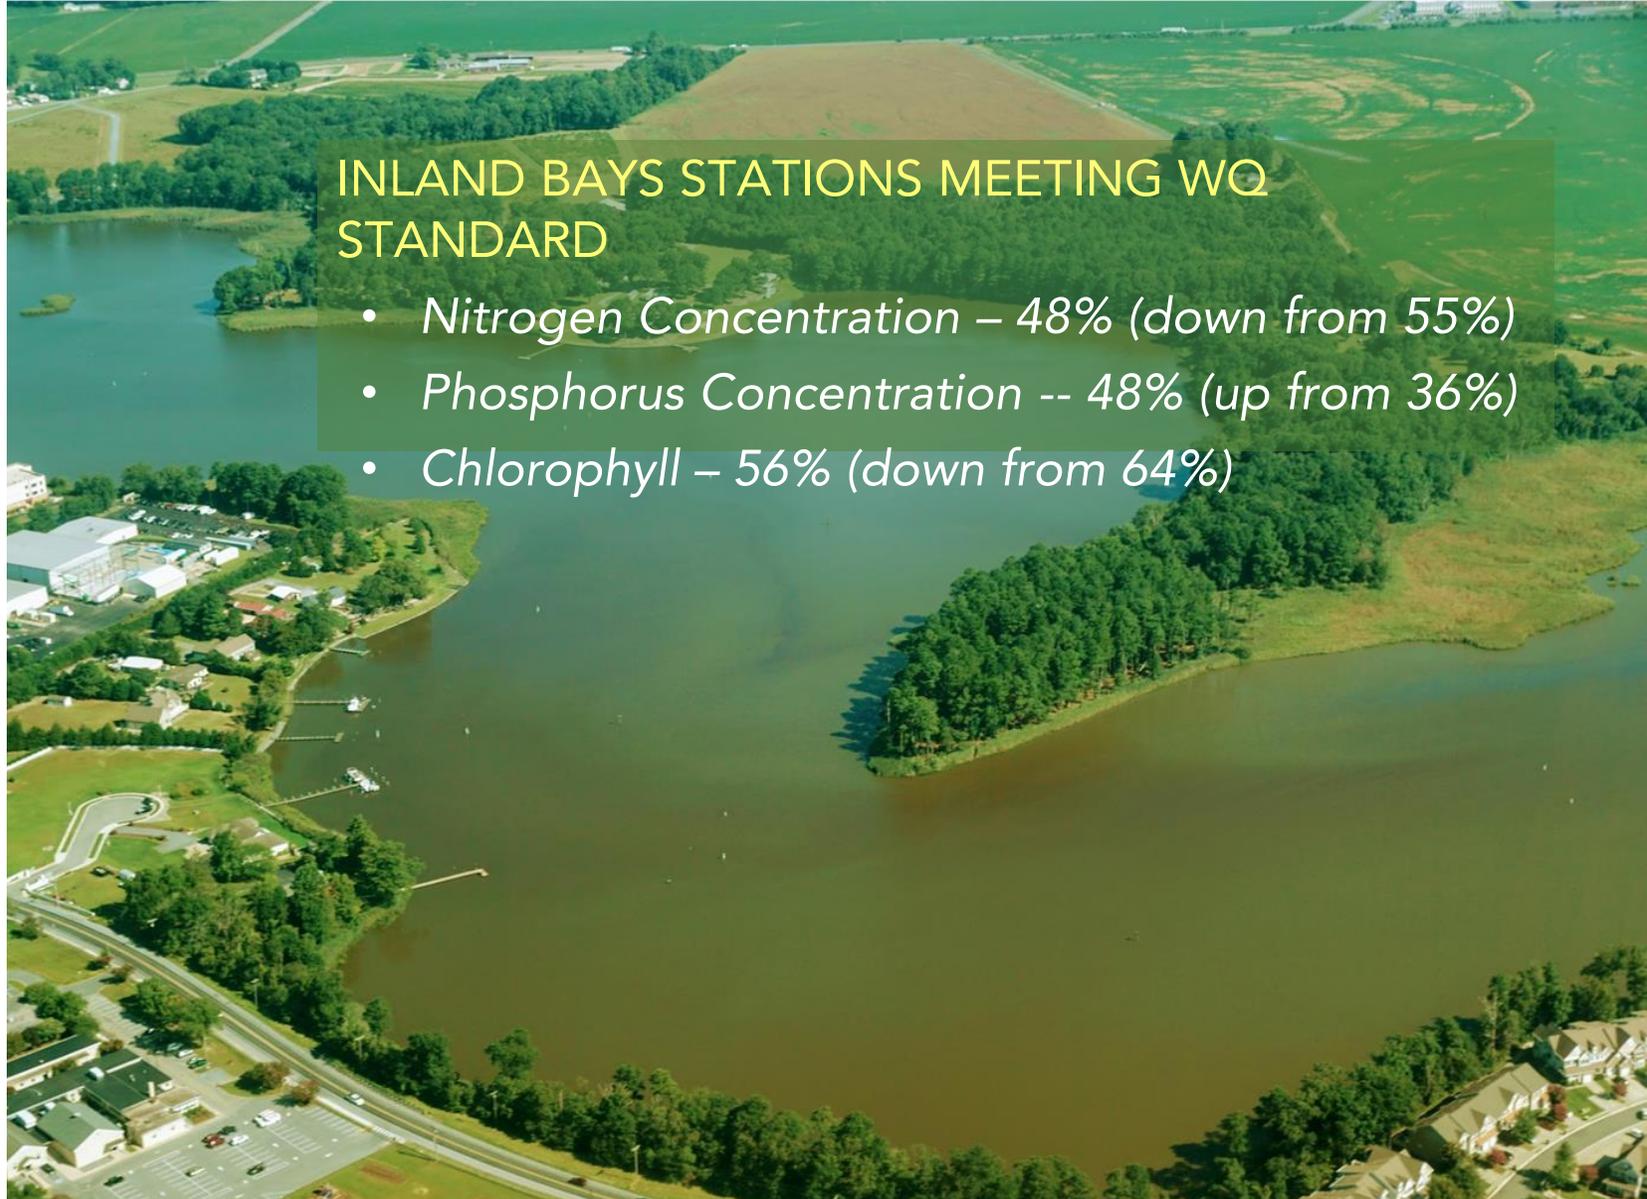
INLAND BAYS STATIONS MEETING WQ STANDARD

- Nitrogen Concentration – 48% (down from 55%)
- Phosphorus Concentration -- 48% (up from 36%)
- Chlorophyll – 56% (down from 64%)

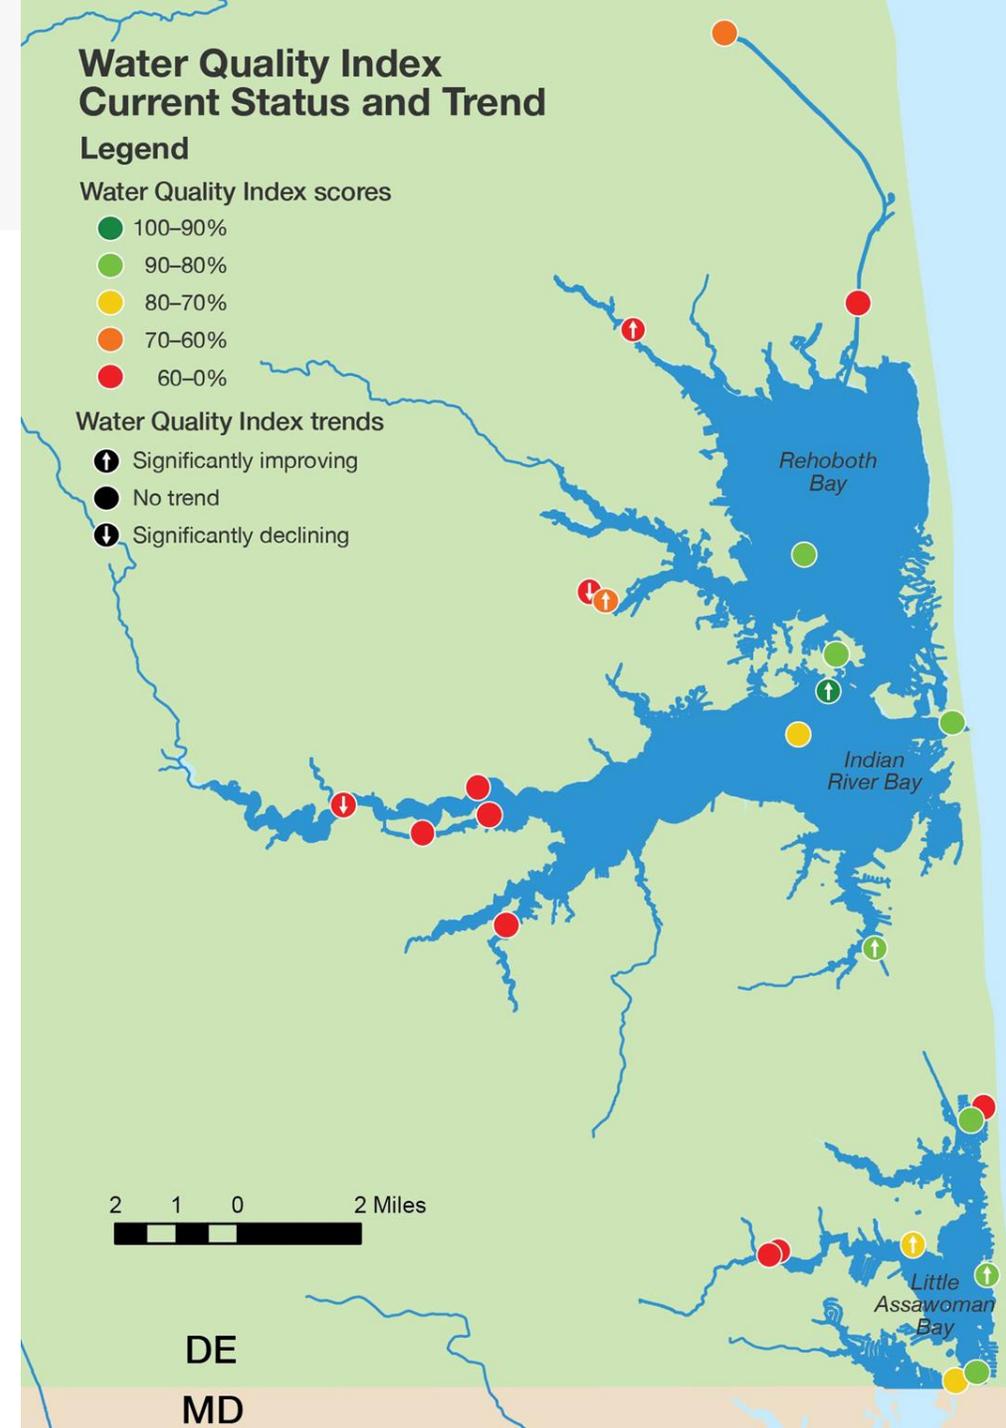
Water Quality Index

New water quality score this year

- Averages N/P concentrations, chlorophyll, and water clarity
- Public-friendly

- Upper IR and tributaries poor
- Open bay areas good
- LAB continuing to improve

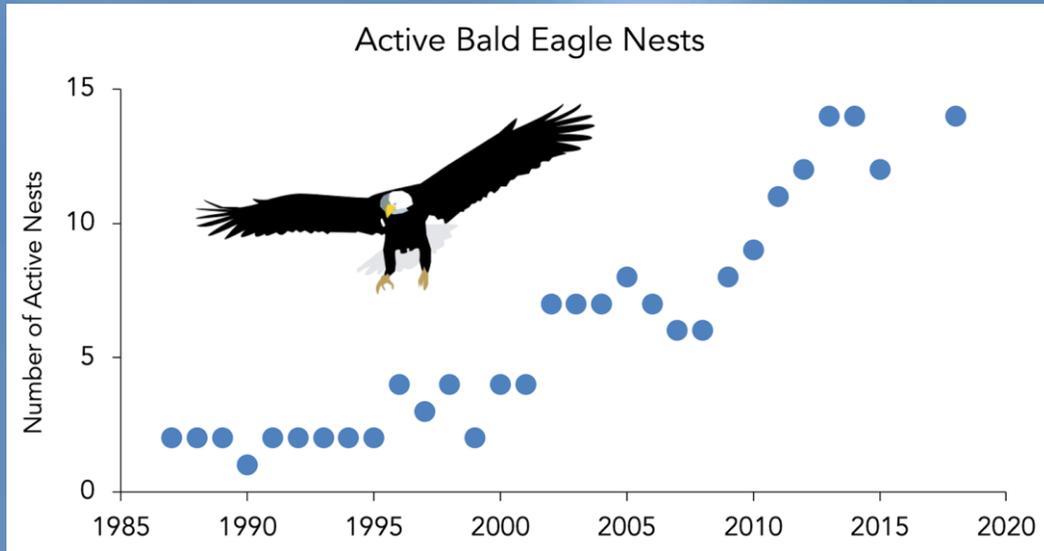
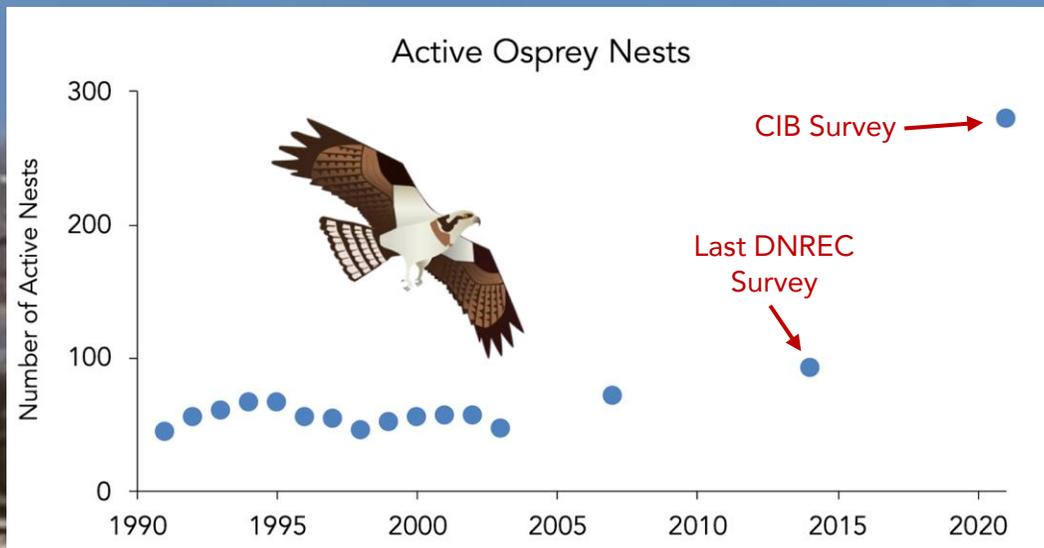
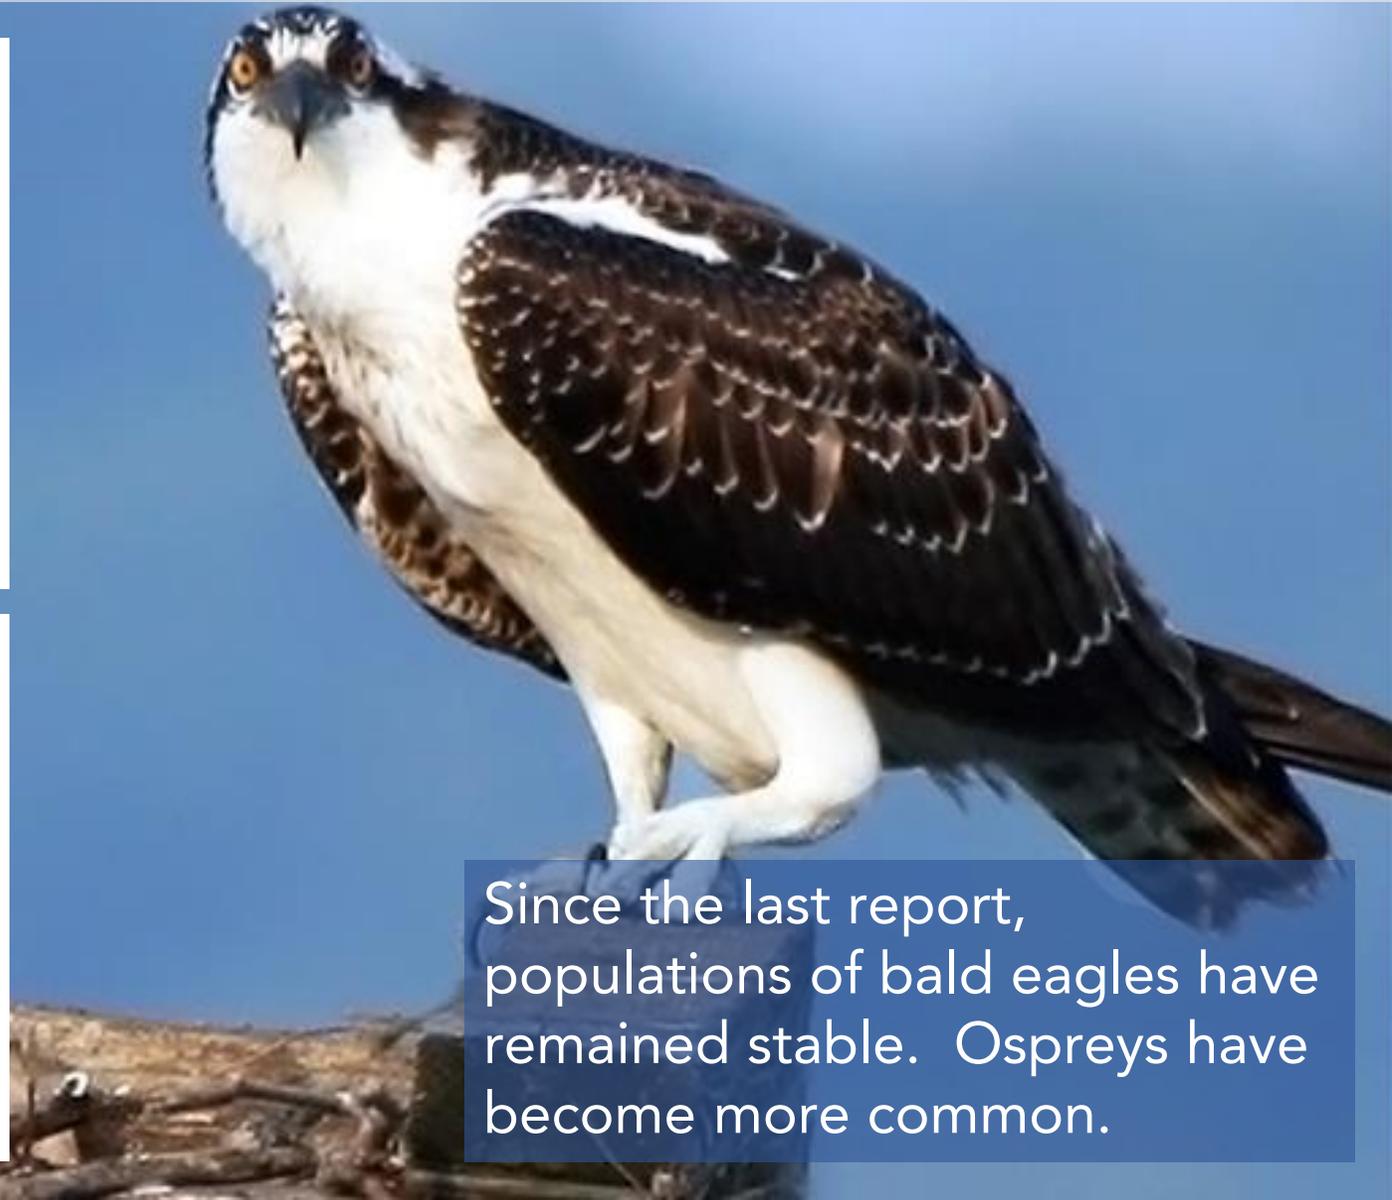
Eagle and Osprey Nesting

Since the last report, populations of bald eagles have remained stable. Ospreys have become more common.

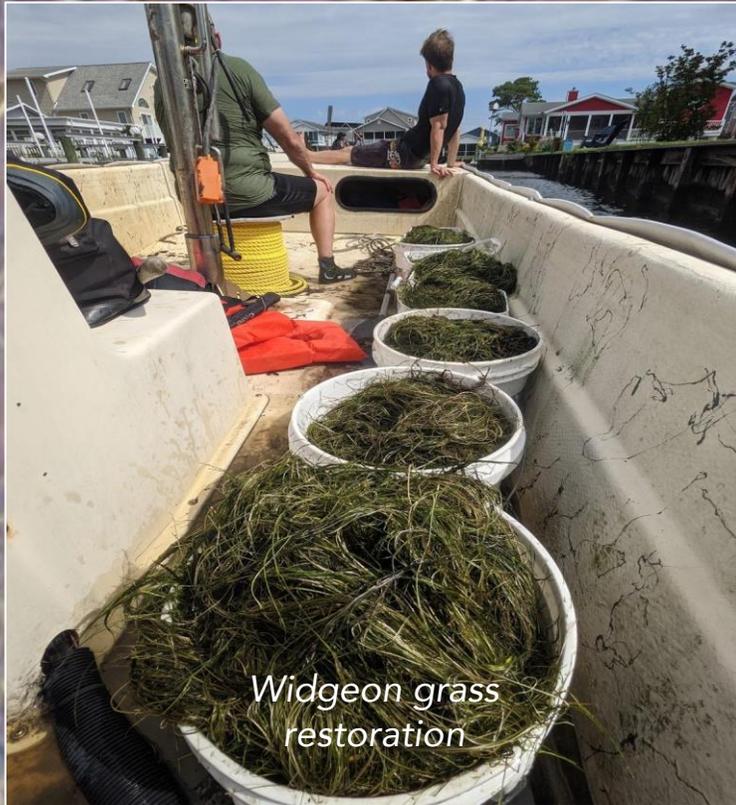
Current Status of Baygrasses in the Inland Bays

- Horned Pondweed -- 9.52 acres
(Love Creek)
- Widgeon Grass – 1.17 acres
(LAB, S. Bethany canals)
- Eelgrass – 0 acres

Nearby estuaries support thousands of acres.

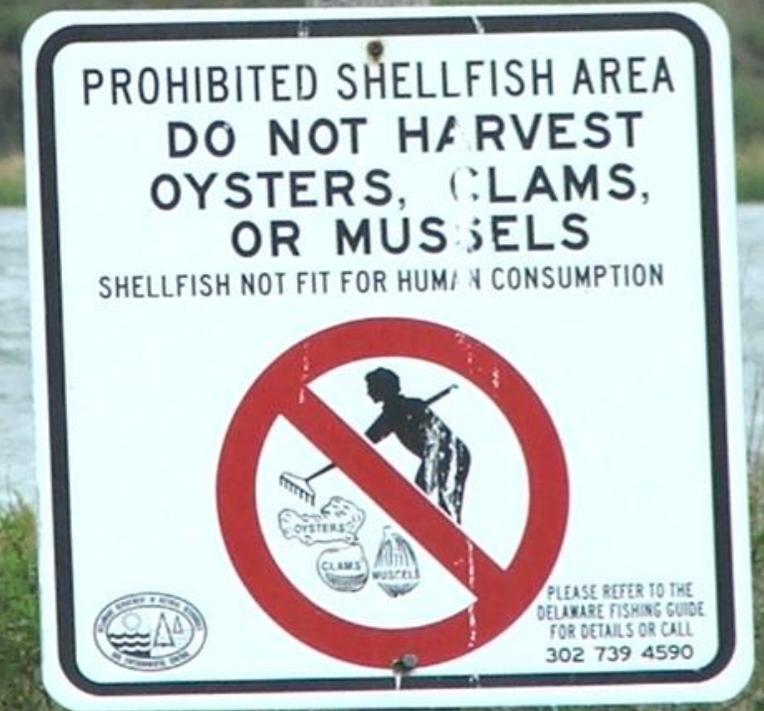
Fecal Bacteria Pollution

- Many tributaries routinely fail to meet the bacteria standard for primary contact (e.g. swimming).
- However, most areas of the bays do routinely meet the standard for other uses.
- Not all of the sources are human, or of equal risk.

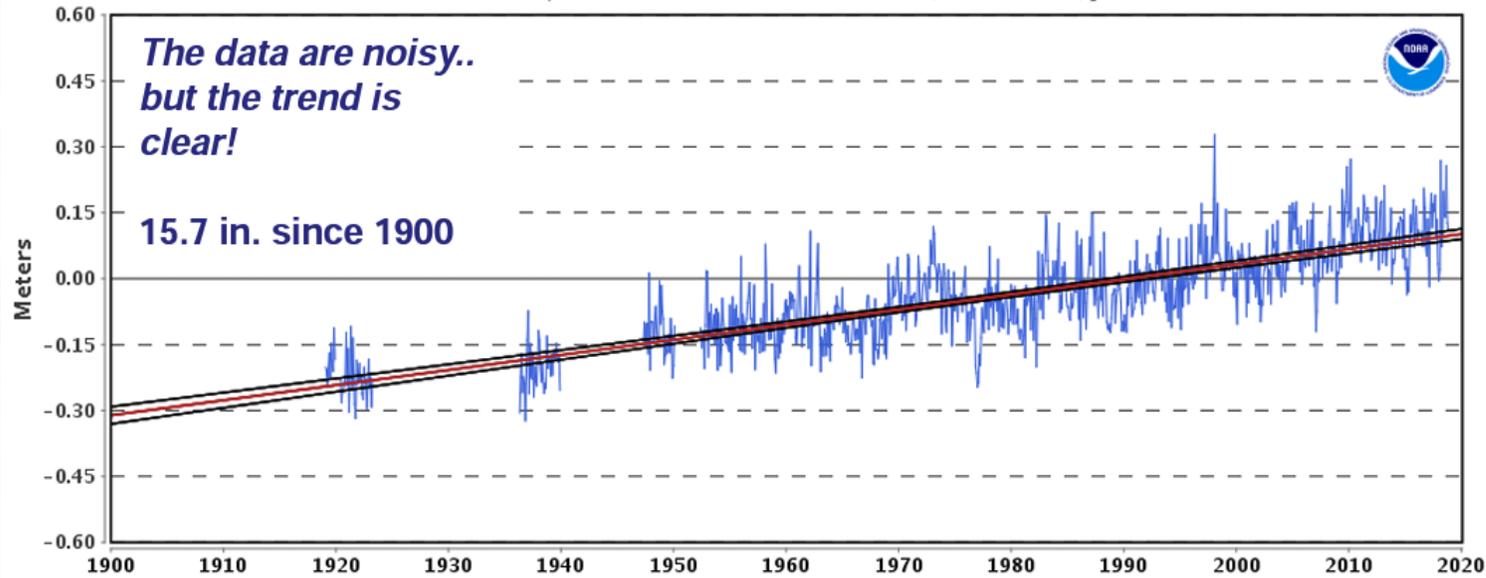
Sea Level Rise

8557380 Lewes, Delaware

3.44 +/- 0.24 mm/yr

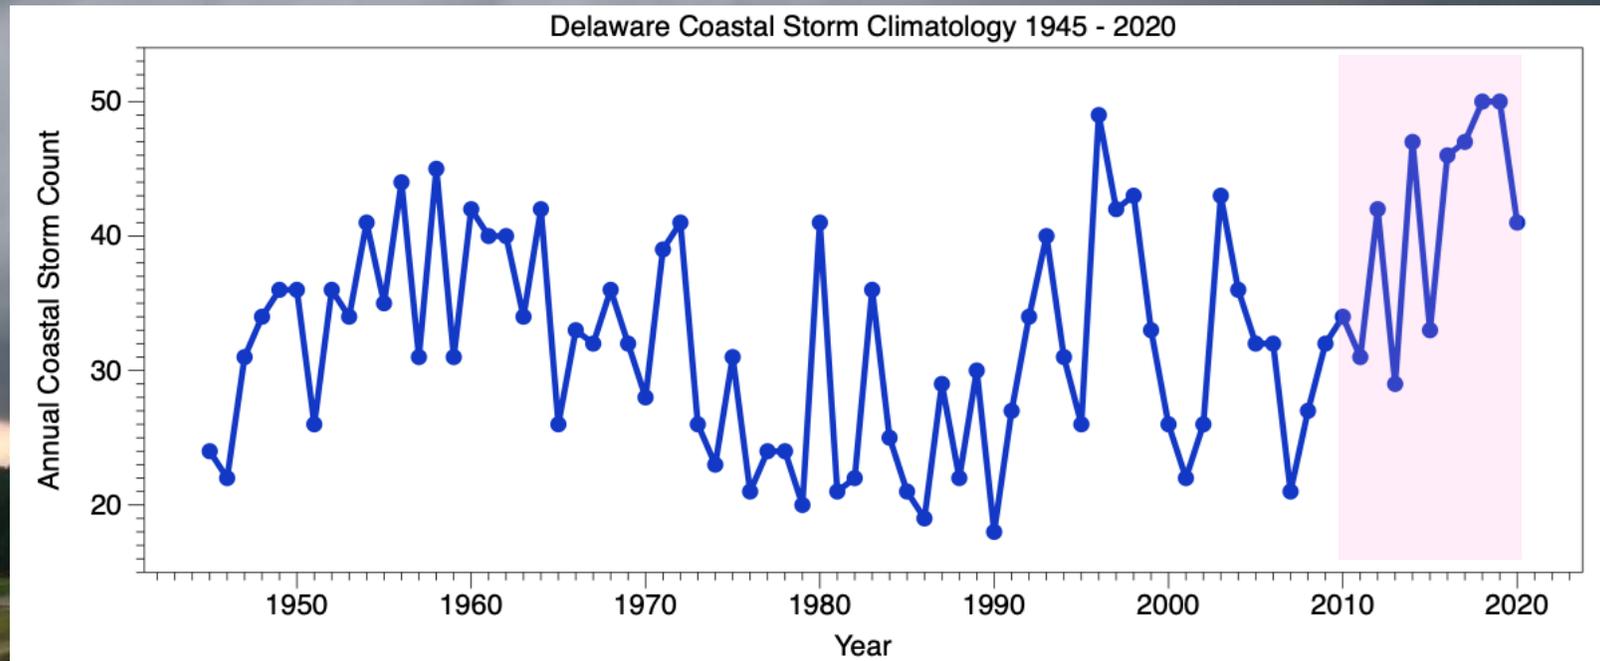
Coastal Storm Frequency

Larger numbers of storms during the last decade.

Greater frequency of intense storms.
