Center for the Inland Bays

How Stream Corridor Watershed Restoration Can Help

July 16, 2010

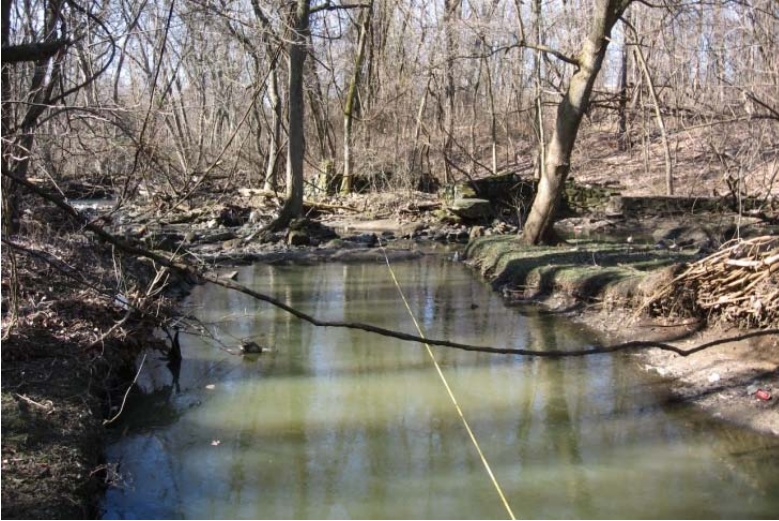
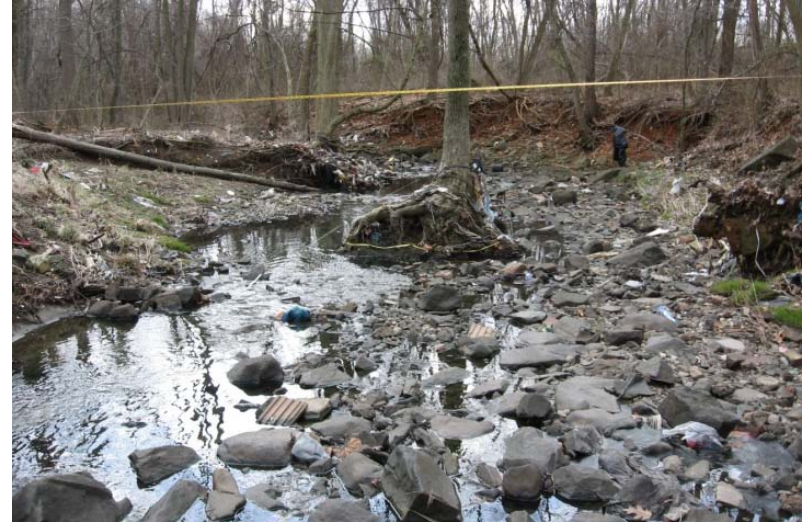
Powder Mill Run - 56% Impervious Cover

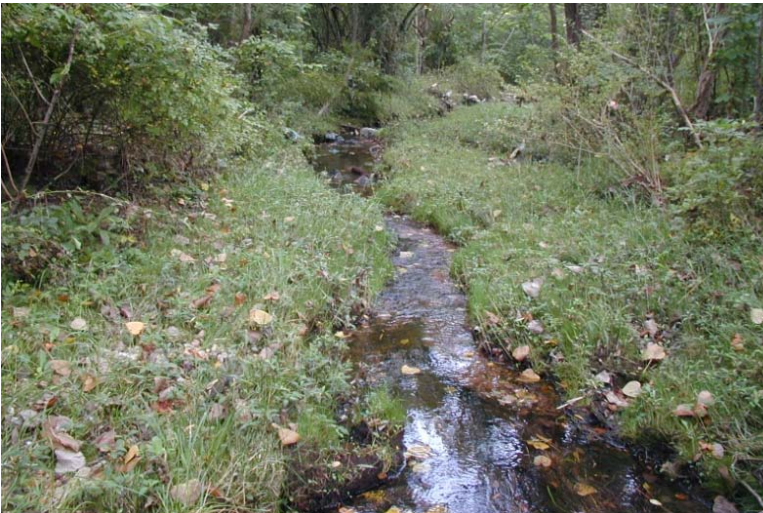
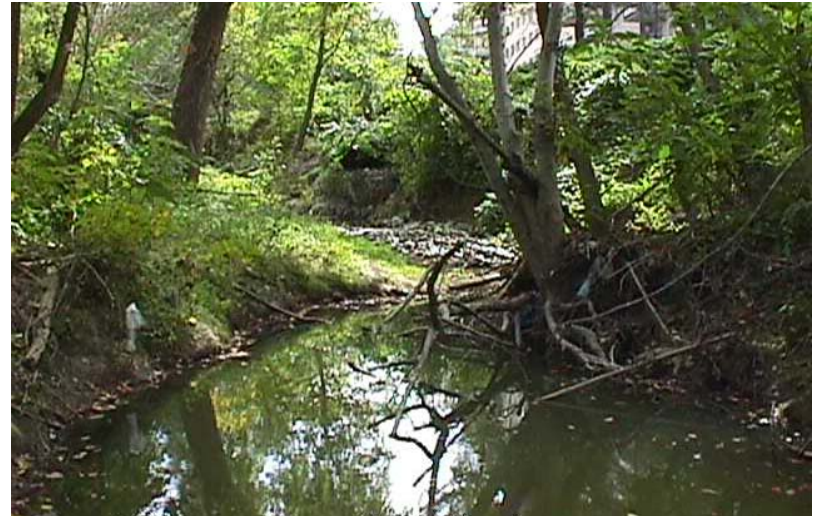
Roland Run - 40% Impervious Cover

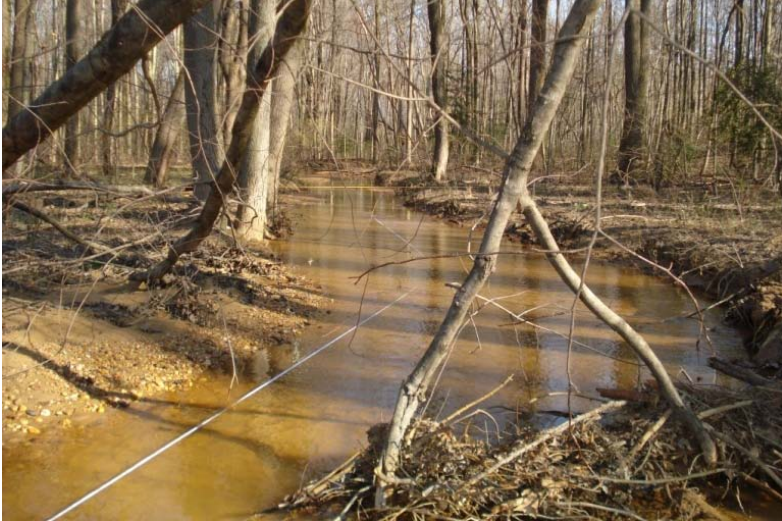
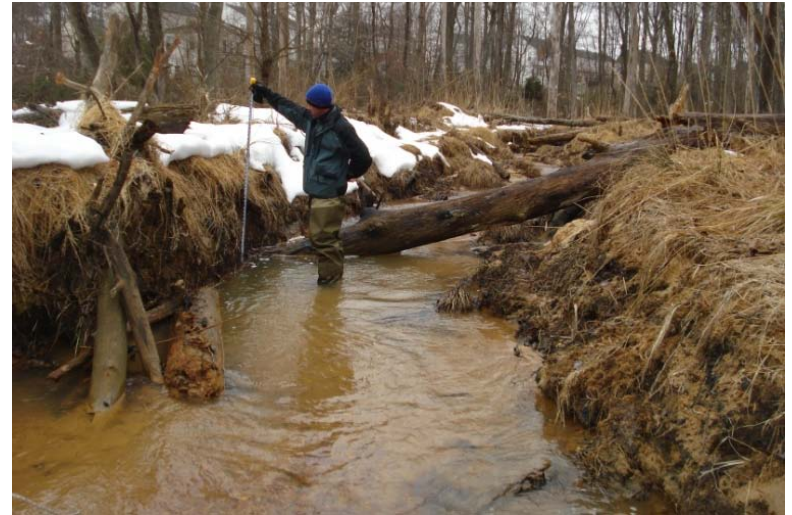
Indian Creek - 24% Impervious Cover

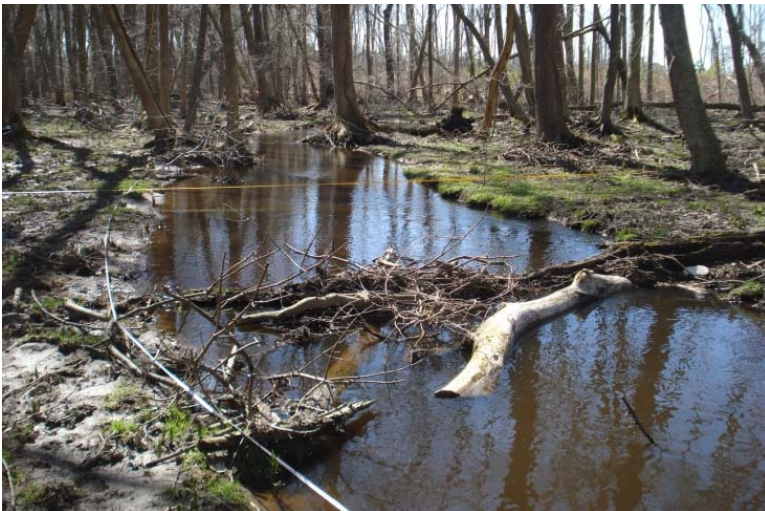
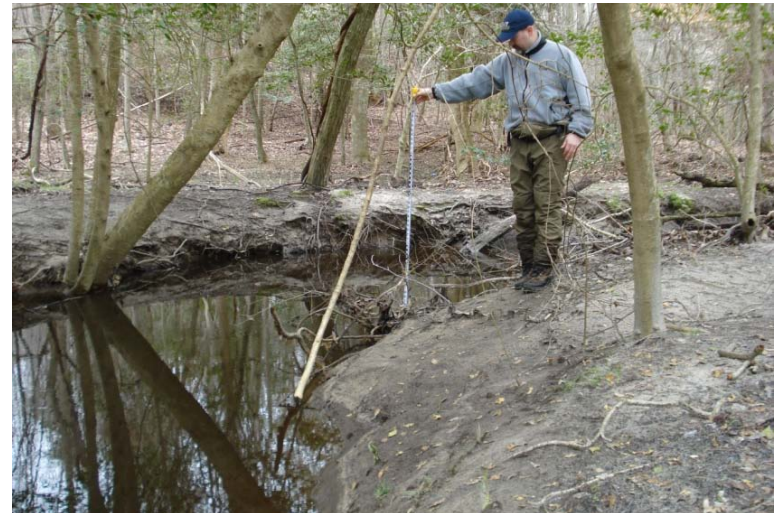
Massey Branch - 2% Impervious Cover

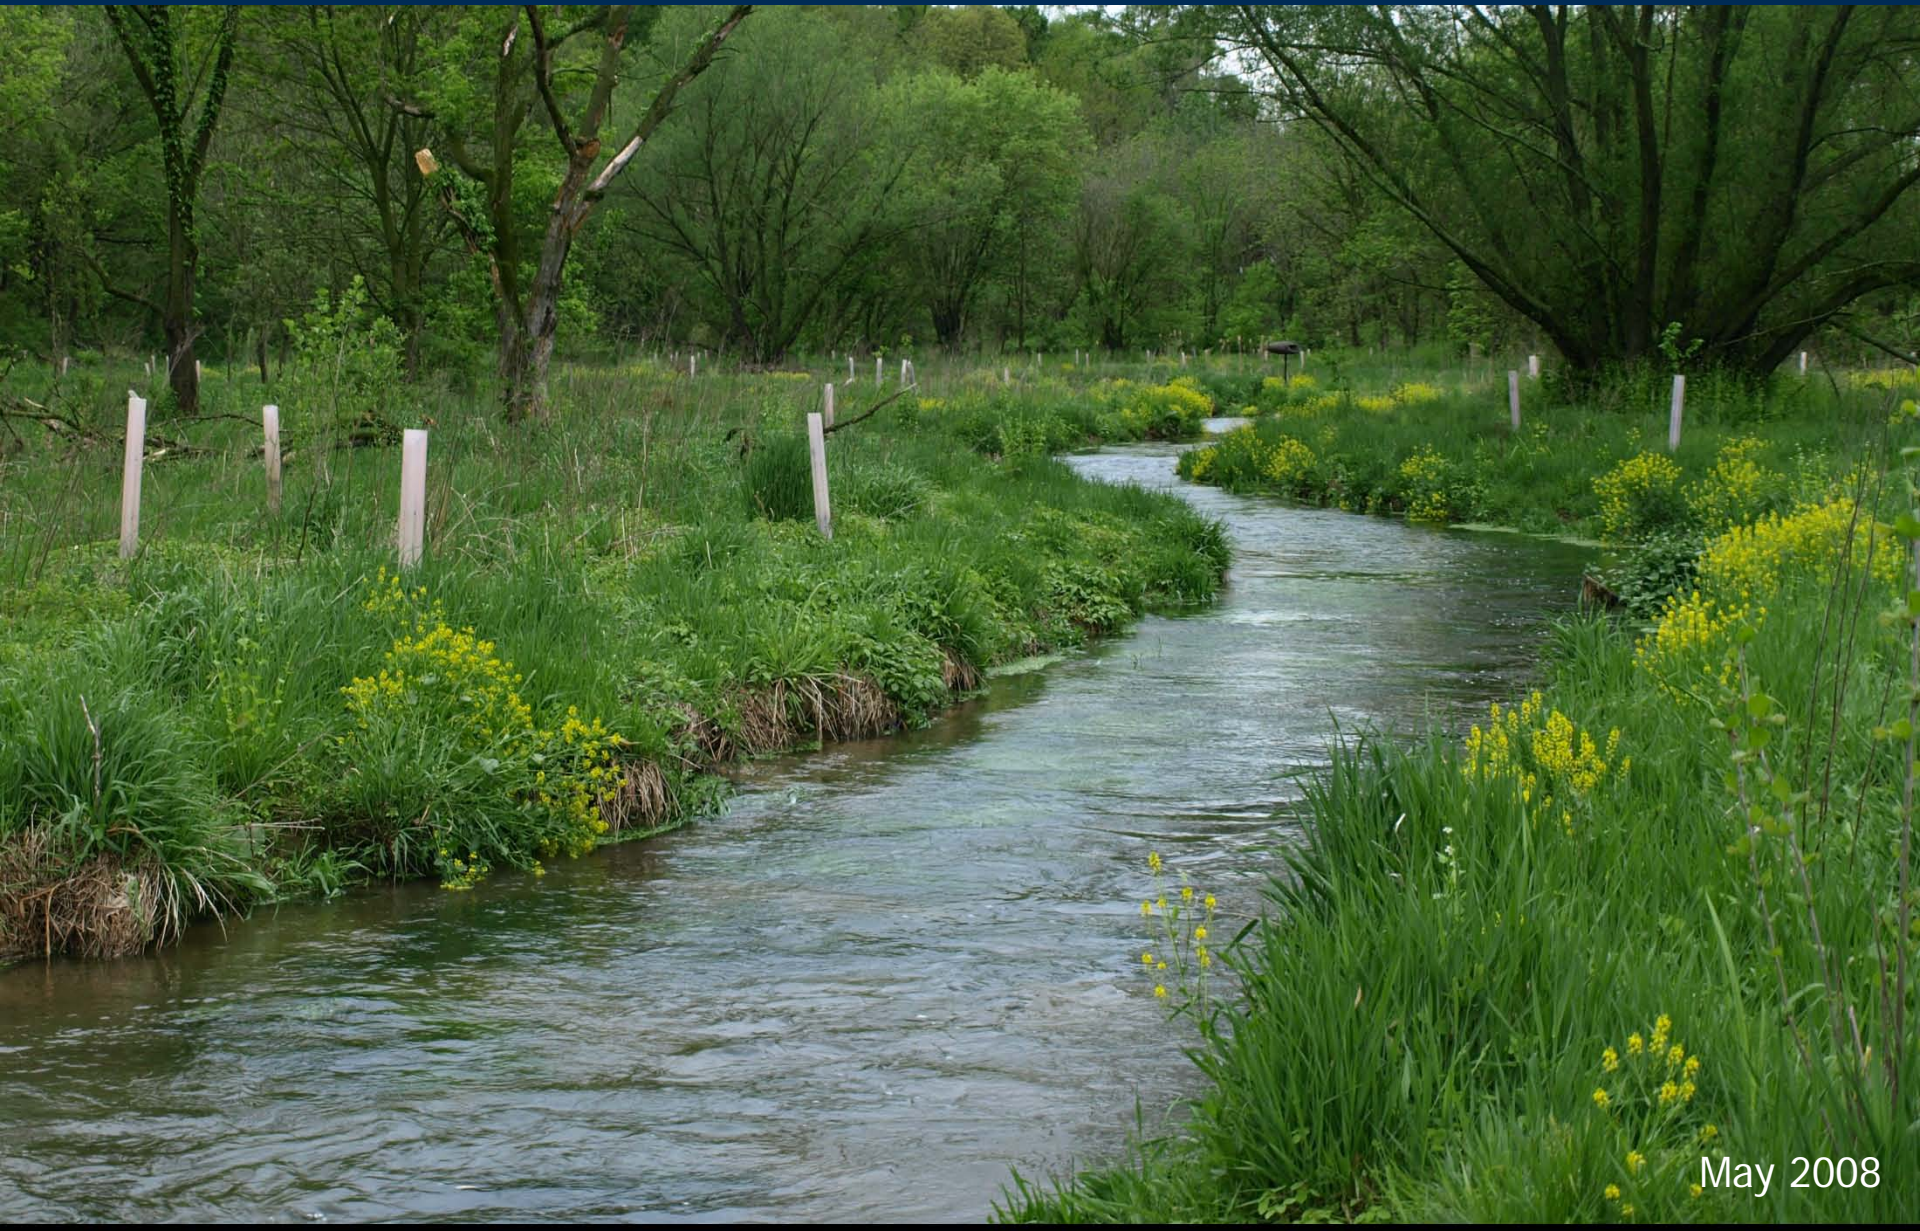
Lititz Run Restoration

Stream relocation and riparian wetland creation

Constructed 2004

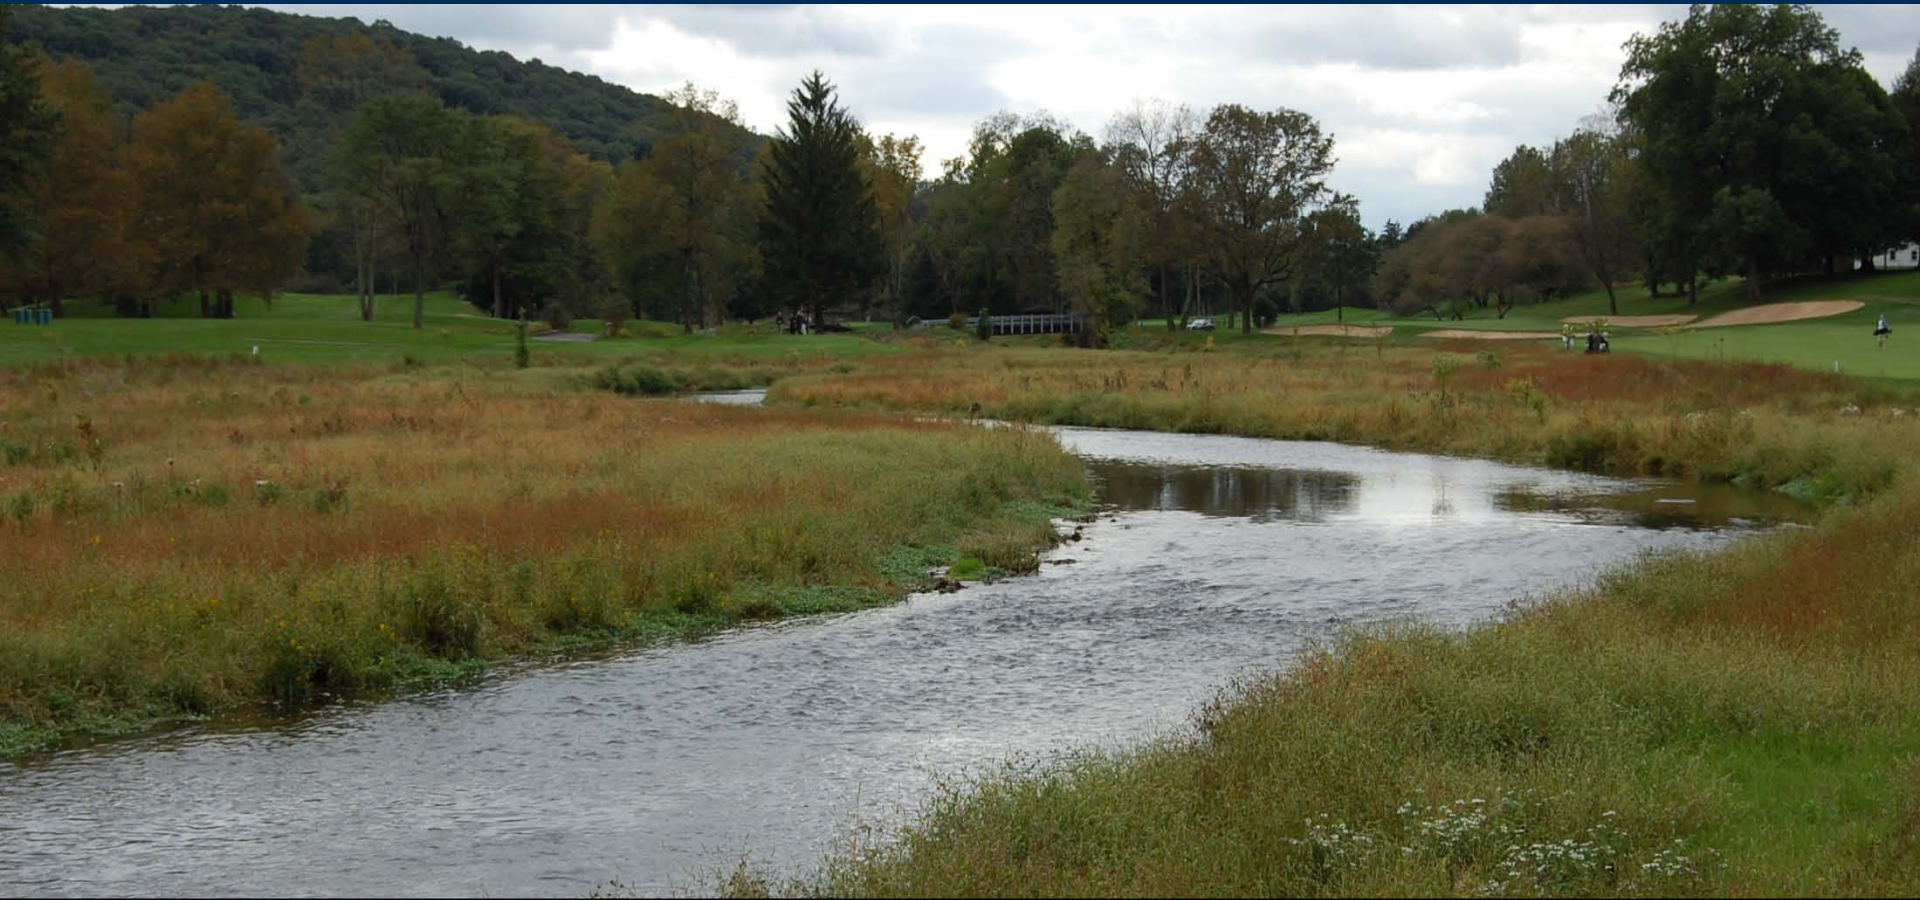
Saucon Creek Restoration

Stream relocation and riparian wetland creation

Constructed 2008

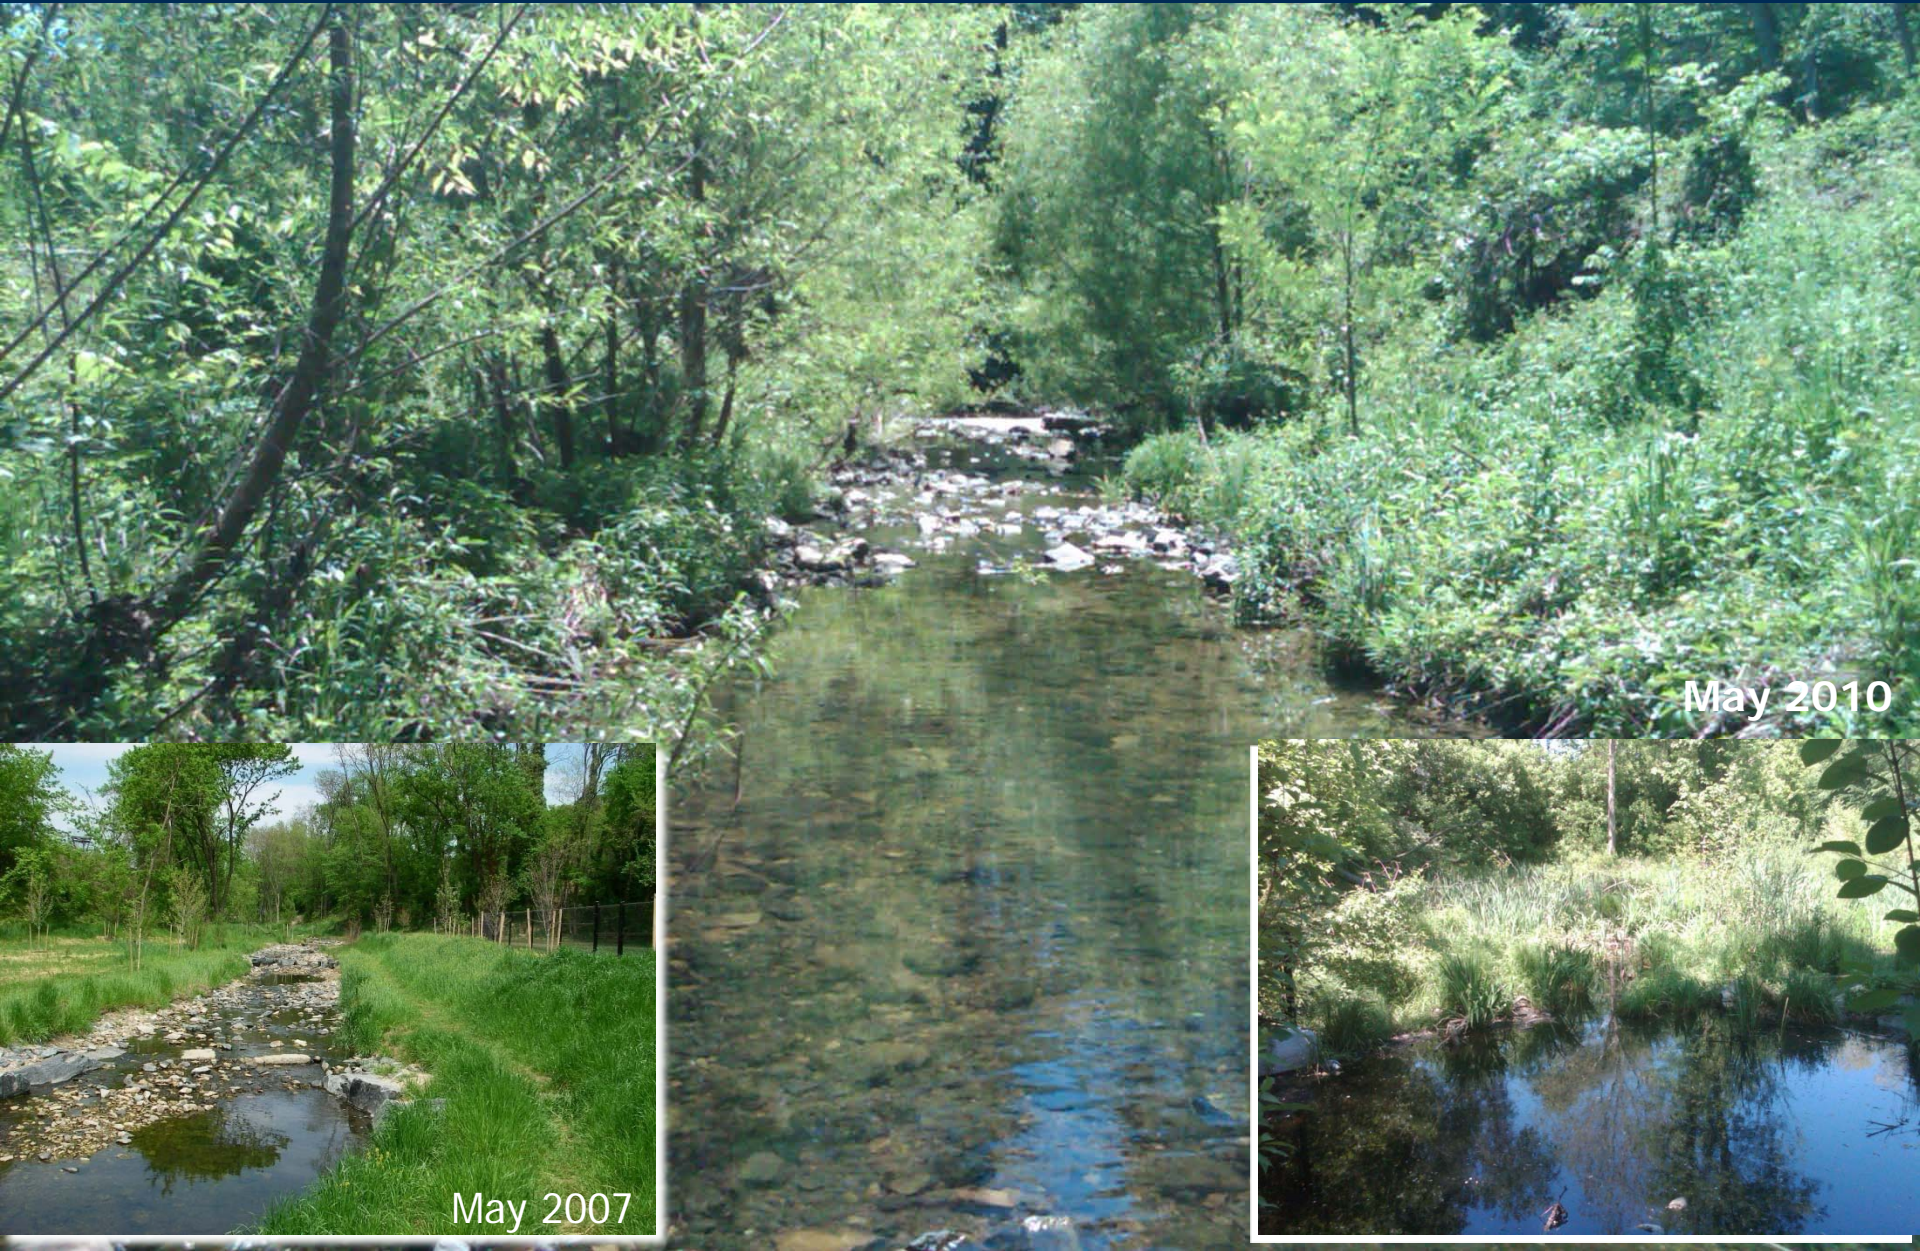
Upper Stony Run Restoration

Urban stream relocation/stabilization and floodplain attachment

Constructed 2006
