THE STATE OF YOUR CREEK

Herring and Guinea Creeks on Rehoboth Bay

The State of Your Creek: Herring and Guinea Creeks on Rehoboth Bay

Marianne Walch, Victoria Spice, and Andrew McGowan
Delaware Center for the Inland Bays

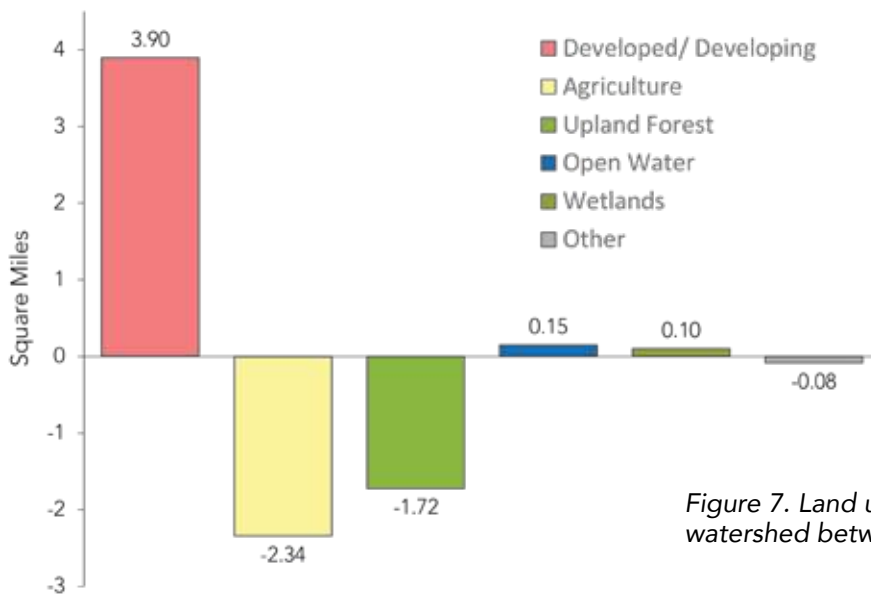
Figure 7. Land use changes in the Herring and Guinea Creek watershed between 1992 and 2012.

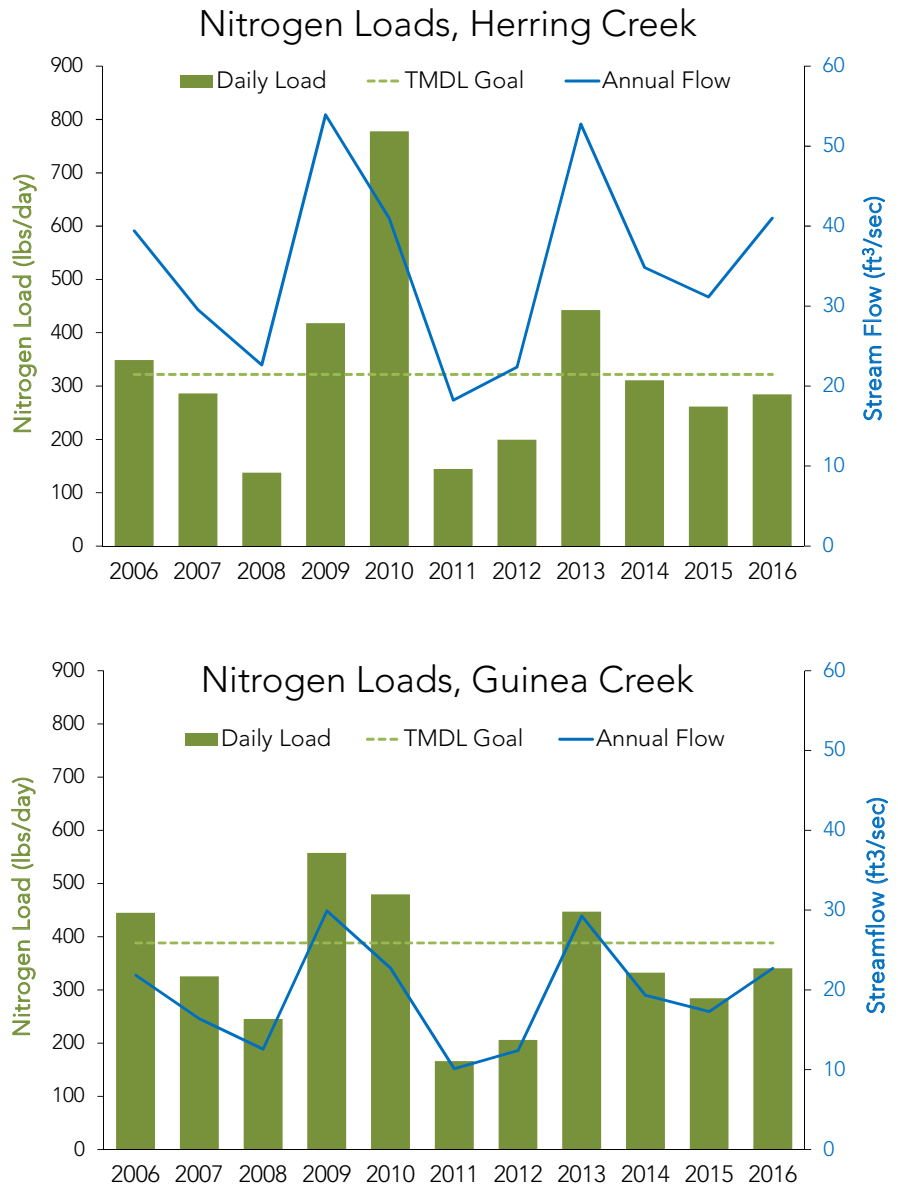
Figure 10. Annual inputs of nitrogen to Herring and Guinea Creeks, with mean annual streamflow for comparison. The Total Maximum Daily Load (TMDL) goal for nitrogen in each creek is indicated by the dashed lines. For the creeks to remain healthy, loads should be below the TMDL goal.

The variation in nutrient loads from year to year is related to stream flow, which is in turn related to the amount of precipitation in a year. During wetter years, the increase in precipitation will cause an increase in runoff from the land. This runoff carries nutrients from farms and residential lawns, bacteria and toxins from developments, and sediment from eroding stream banks and construction sites, and delivers them to the creeks.

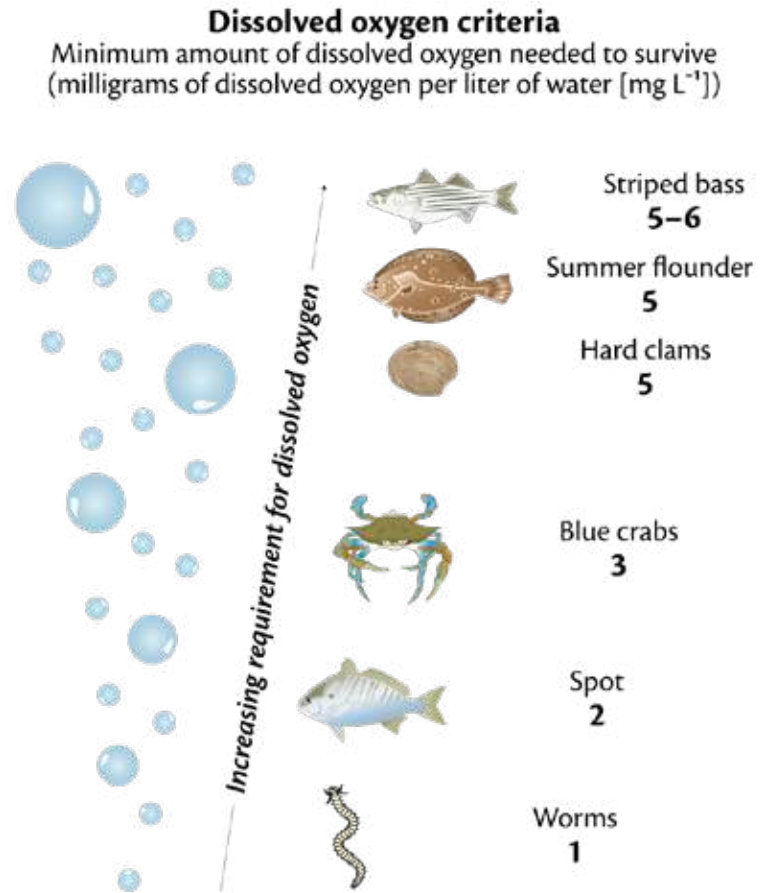
Figure 14. Different organisms require different levels of dissolved oxygen in the water to survive. Dissolved oxygen is a useful indicator of water quality. Diagram courtesy of the Integration and Application Network, ian.umces.edu.

All aquatic life needs healthy concentrations of oxygen in the water (Figure 14). Healthy, stable concentrations of oxygen are especially important in tidal creek nursery grounds where young fish, crabs, and shellfish are found.

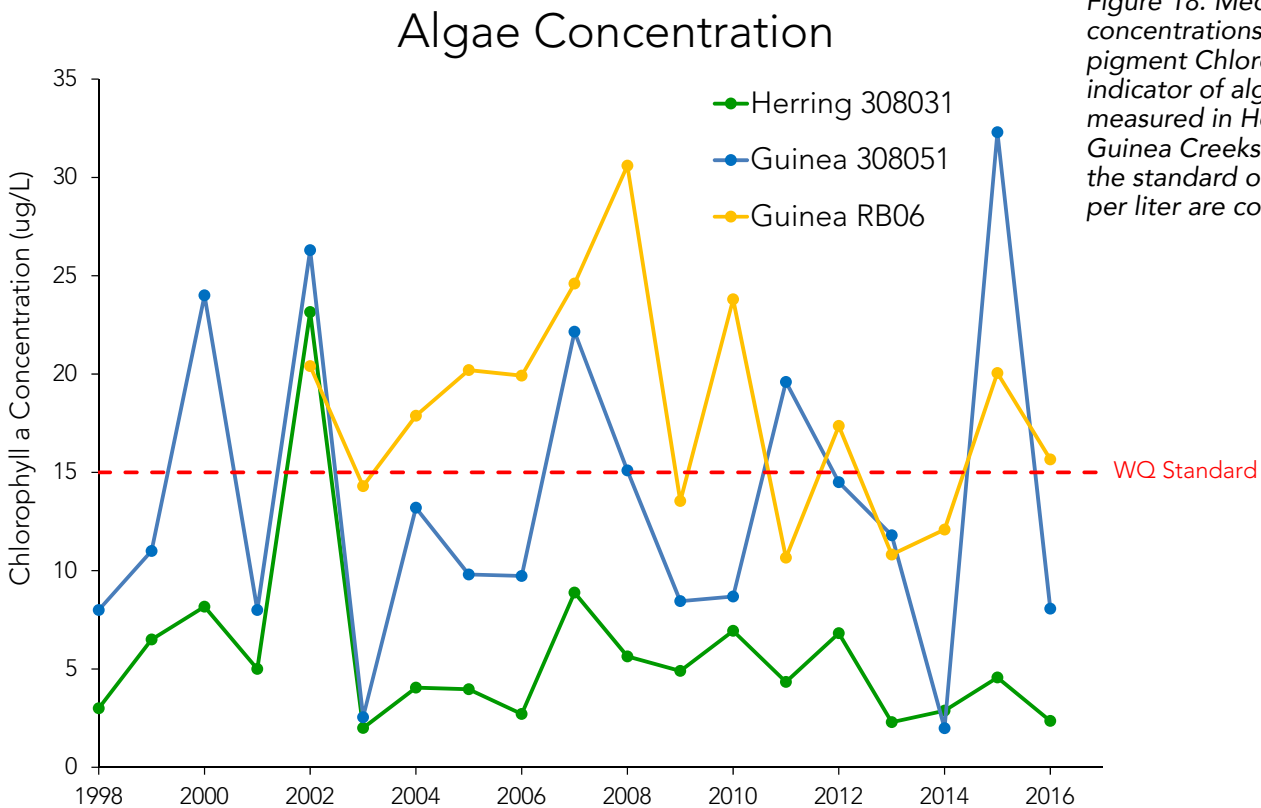
Figure 18. Median annual concentrations of the algal pigment Chlorophyll-a (an indicator of algae abundance) measured in Herring and Guinea Creeks. Values below the standard of 15 micrograms per liter are considered healthy.

Concentrations of algae in Guinea Creek, however, often fail to meet the water quality standard. There does appear to be a slight downward trend in algae concentration at the Guinea Creek monitoring stations, though, and median values are approaching healthy levels. This is a good sign if it continues.

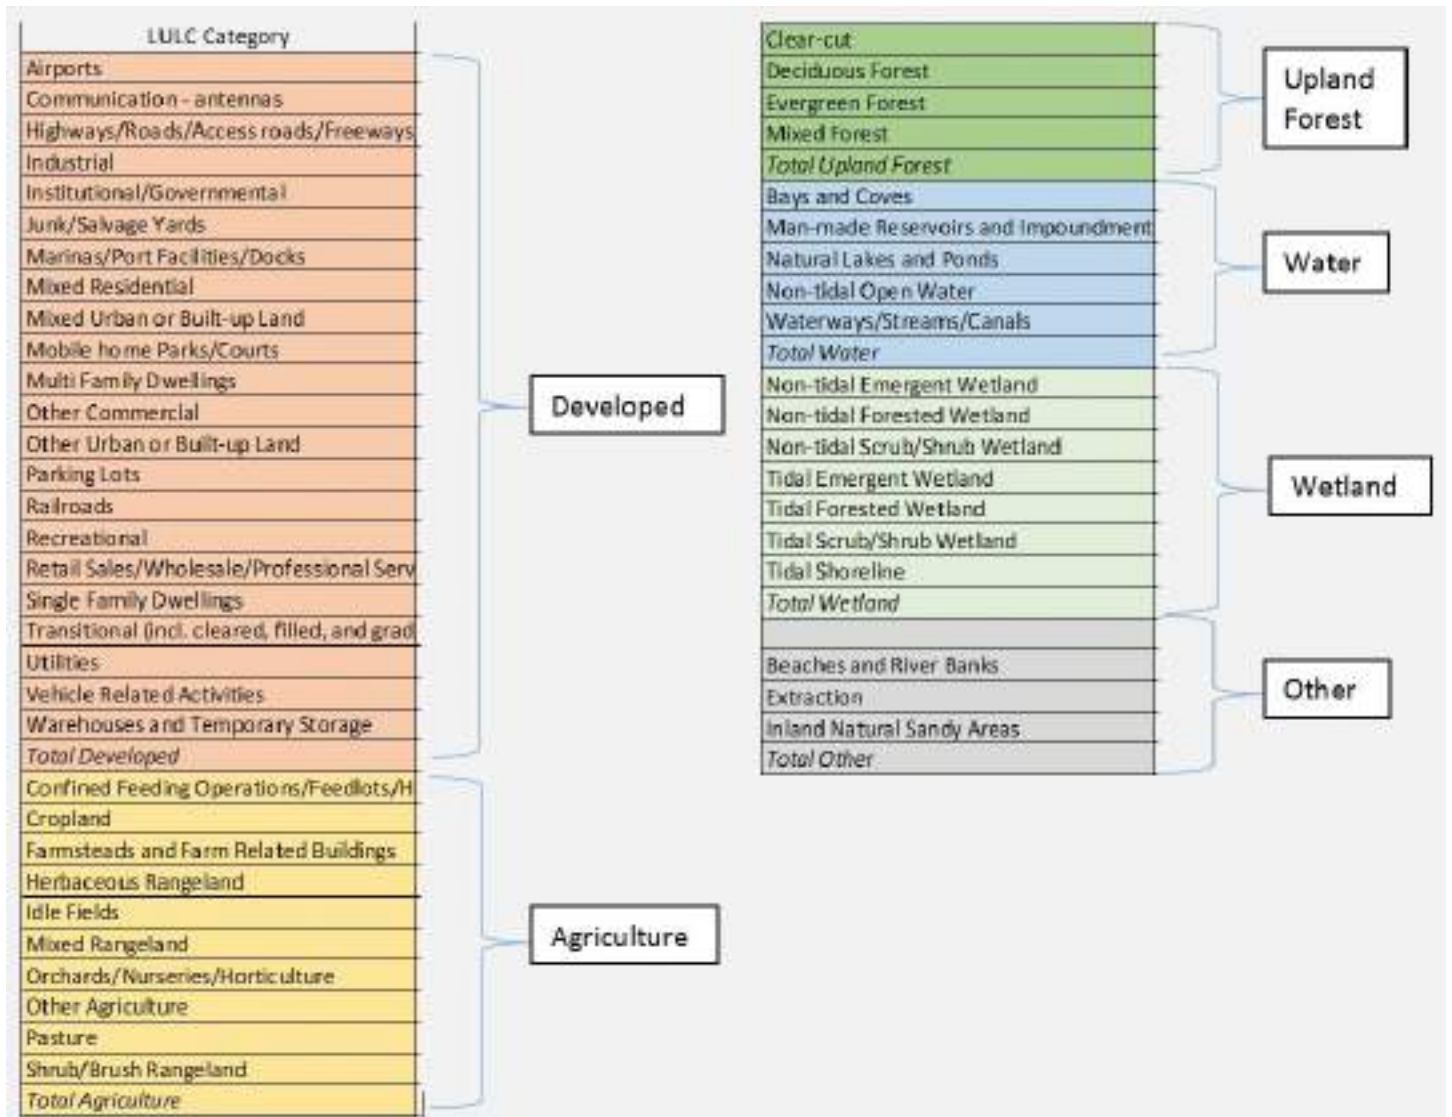
Figure A-2. Land use change in the Herring and Guinea Creek watershed, 1992-2012.

Figure A-2 summarizes the changes across the six categories, within the Herring and Guinea Creek watershed, for each of the five year periods. The percent of land use for each broad category from 1992 was compared to the current percent in the 2012 land use data.
