Assateague pointe Berlin, Maryland

LONG-TERM CAPITAL RESERVE STUDY

ASSATEAGUE POINTE HOMEOWNERS ASSOCIATION 8552 STEPHEN DECATUR HIGHWAY BERLIN, MARYLAND 21811

November 2023

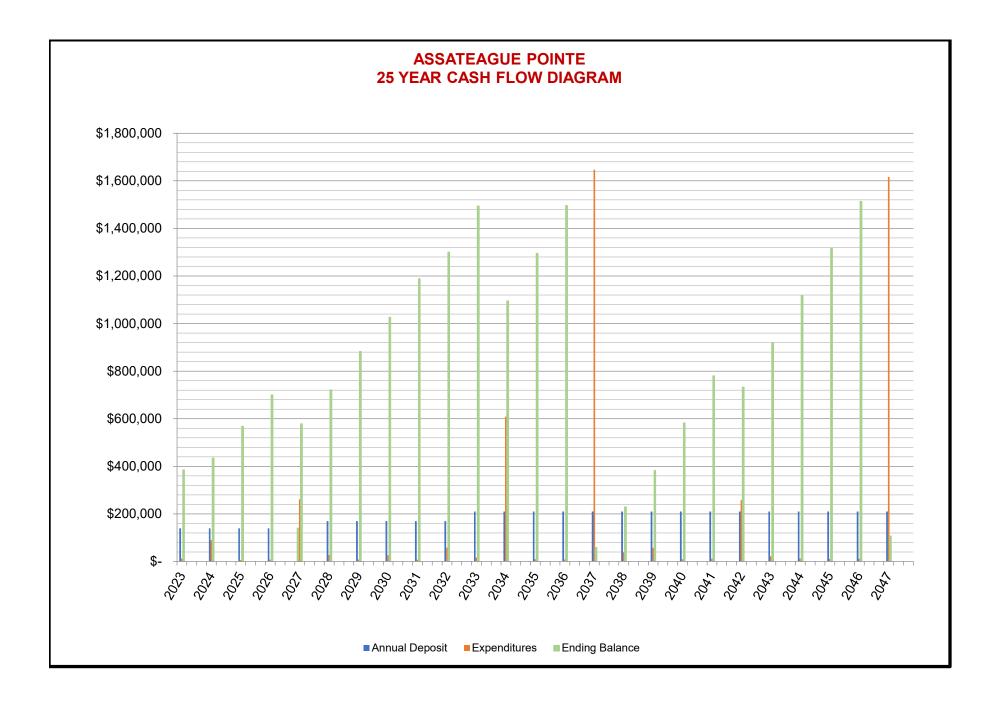
TWENTY- FIVE YEAR CASH FLOW DIAGRAM

This is based on an assumed inflation rate of 3.0% and an assumed interest rate of 2.0%. Attached to this report you will find an Inventory of Components sheet, Schedule of Replacements, Cash Flow Graph, and an Items Sheet. The Inventory of Components sheet attached includes the following for each component: Estimated Useful Life, Estimated Remaining Useful Life, Quantity, Unit Replacement Cost, Estimated Current Replacement Cost, Current Funding Requirement, and the Annual Funding Requirement for each component. The Schedule of Replacements attached indicates which components need to be replaced, and in what time frame. A 25-year Cash Flow Diagram is provided, and indicates the estimated deposits, expenditures, and ending balance over the next 25 years for this condominium association's reserve fund. Finally, the Items Sheet provides an overview assessment of each component, including a photograph, description, and evaluation of the component.
